Ancona (Section of a Predella) with the “Crucifixion and Passion Scenes”

**FINAL RESTORATION REPORT
JULY 2024**

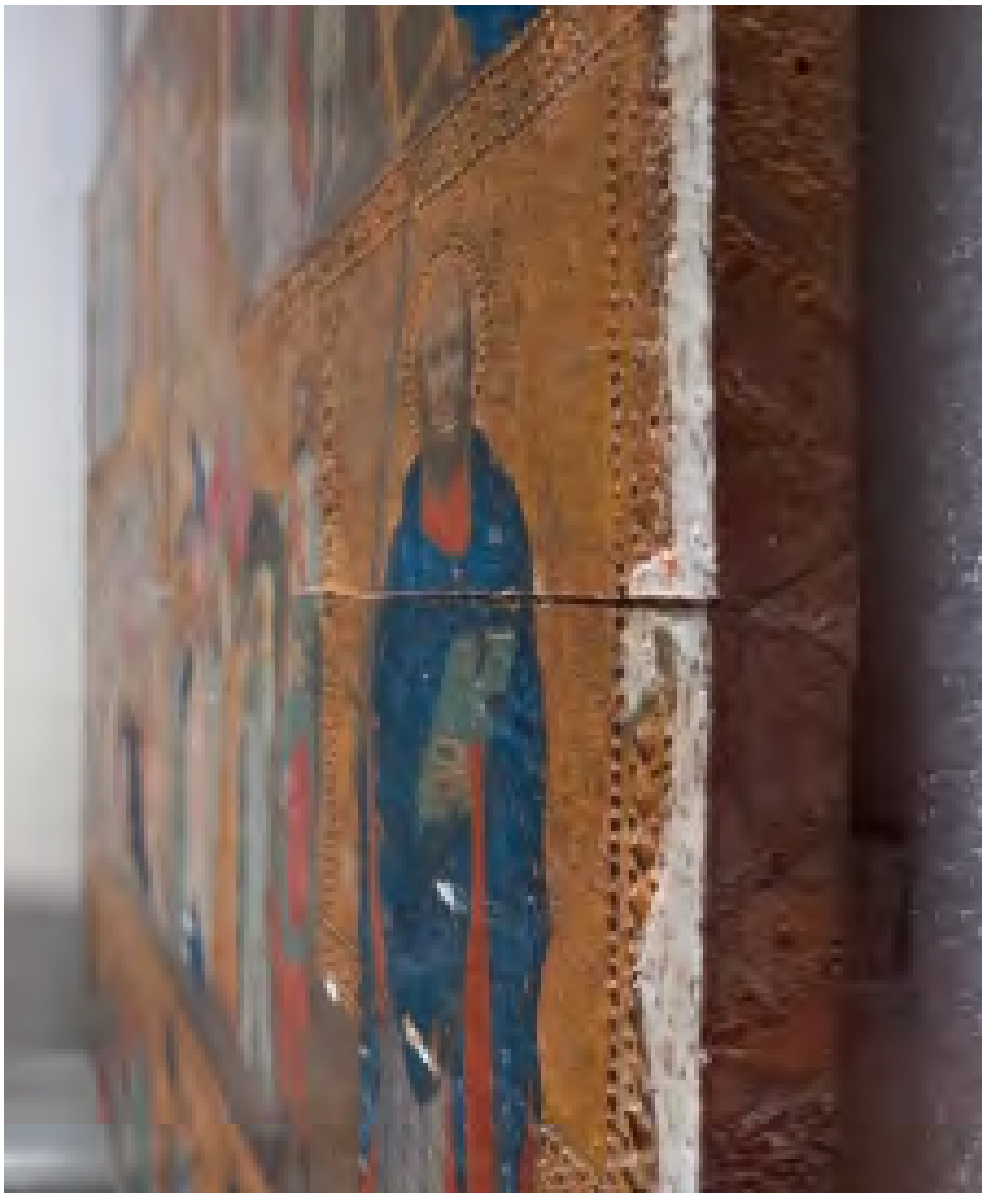
The restoration of the panel of the Crucifixion and Scenes from the Passion by Alesso D'Andrea had the purpose of repairing a conspicuous horizontal lesion. On closer inspection, the restorer found that the lesion ran through the entire thickness of the wooden support at the junction of the two axes that make it up.

Wooden support damage

On the reverse side, the restorer also noted that some catches supporting the brass crossbars had lost their adhesion, so the containment system was no longer functional.

After fixing the lifts with a suitable opaque consolidant, the restorers from the Wood Laboratory restored the structure of the painting. Restorers tested various solutions and methods to remove the overlying layers while fully respecting the original layers.

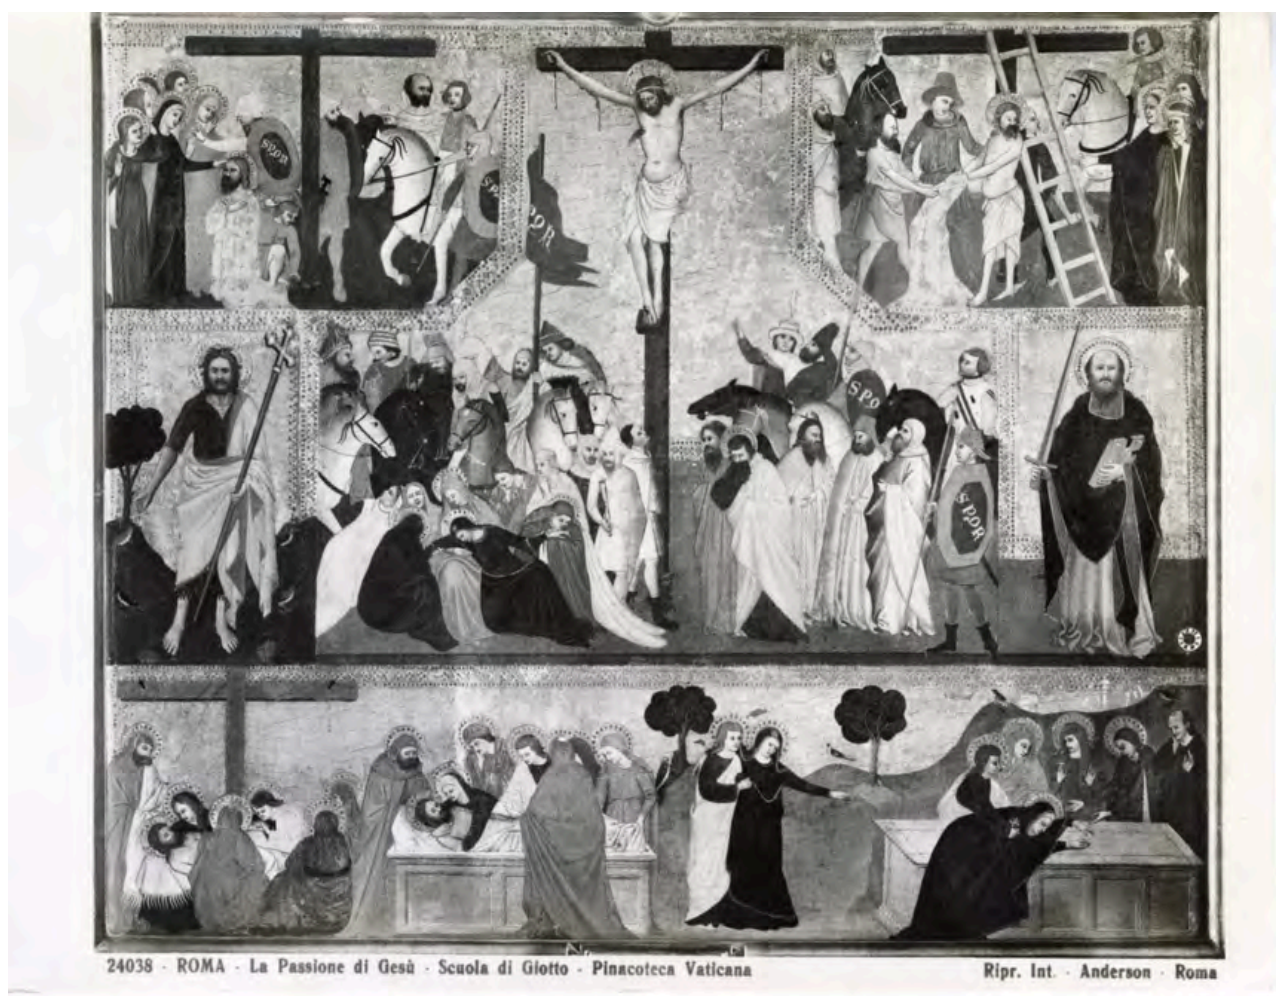
The worst damage probably occurred during this transportation, with the loss of the original perimeter borders and surface finishes of the figures depicted. In particular, the modeling of most of the draperies has disappeared, reducing them to monochrome silhouettes without *chiaroscuro*. Subsequently, the scenes were extensively repainted to remedy the shortcomings, with the draperies, tree crowns, and even the perimeter punching repainted.

The repainting found before the 1968 restoration

However, the only documented intervention is that carried out in the Vatican in 1968 by the restorer G. Colalucci: he repaired the delicate film of paint, removed all the repainting to recover the remaining original surface, and, finally, reinstated the numerous gaps using vertical hatching in neutral colors, as was the practice in restorations at the time.

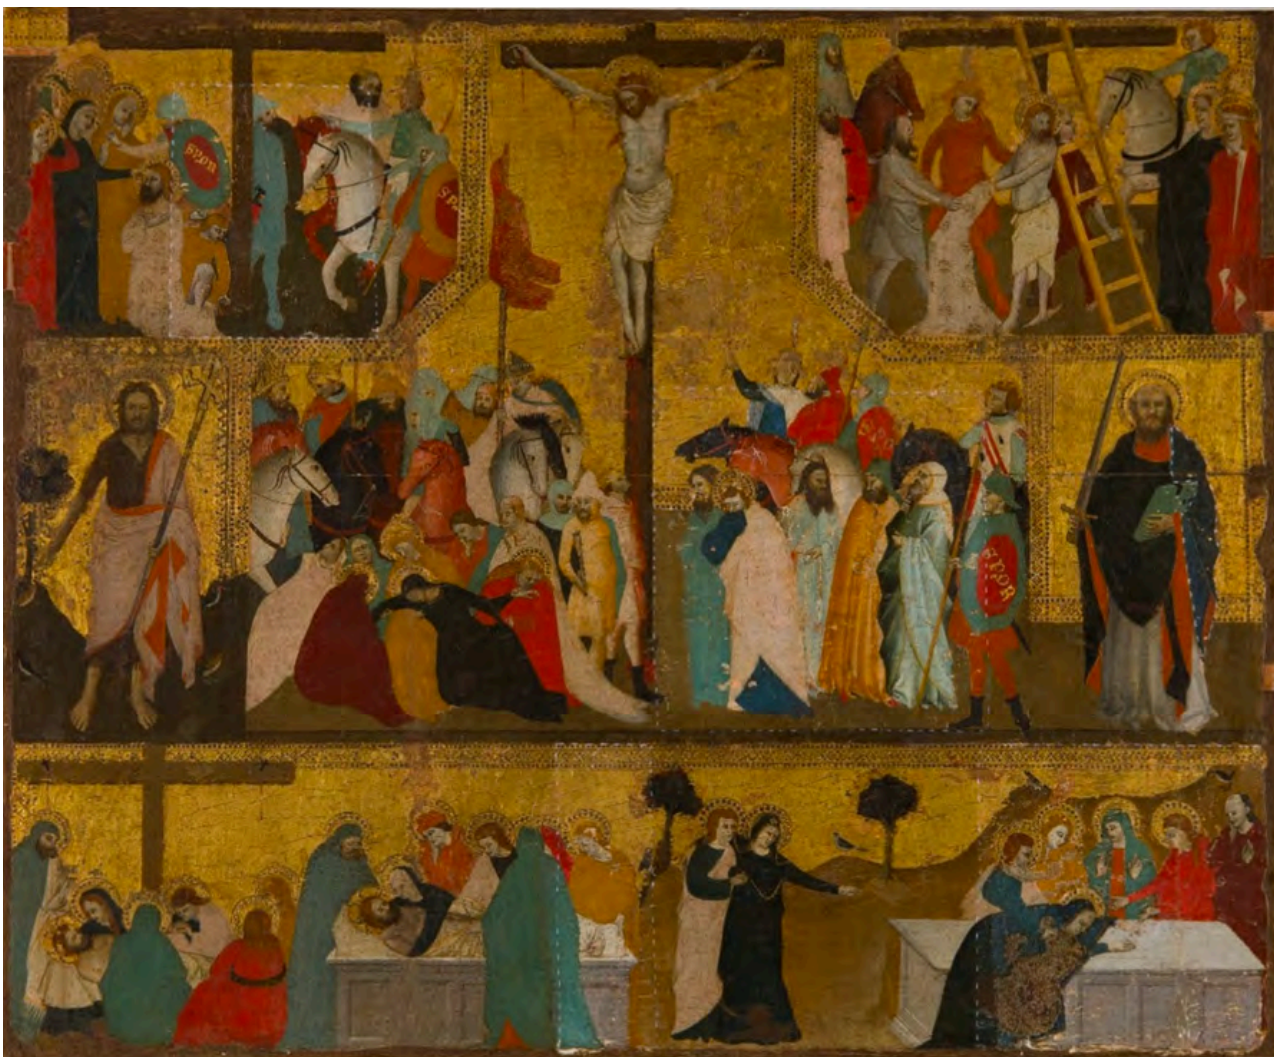
As a result of the retouches and the protective varnish of the latter restoration, as well as the original blue pigment of some of the drapery, which had now changed to black, the painted surface appeared chromatically altered; in addition to the structural problems already mentioned, there were also numerous lifts of the paint film in the lower register.

State of preservation and first cleaning tests

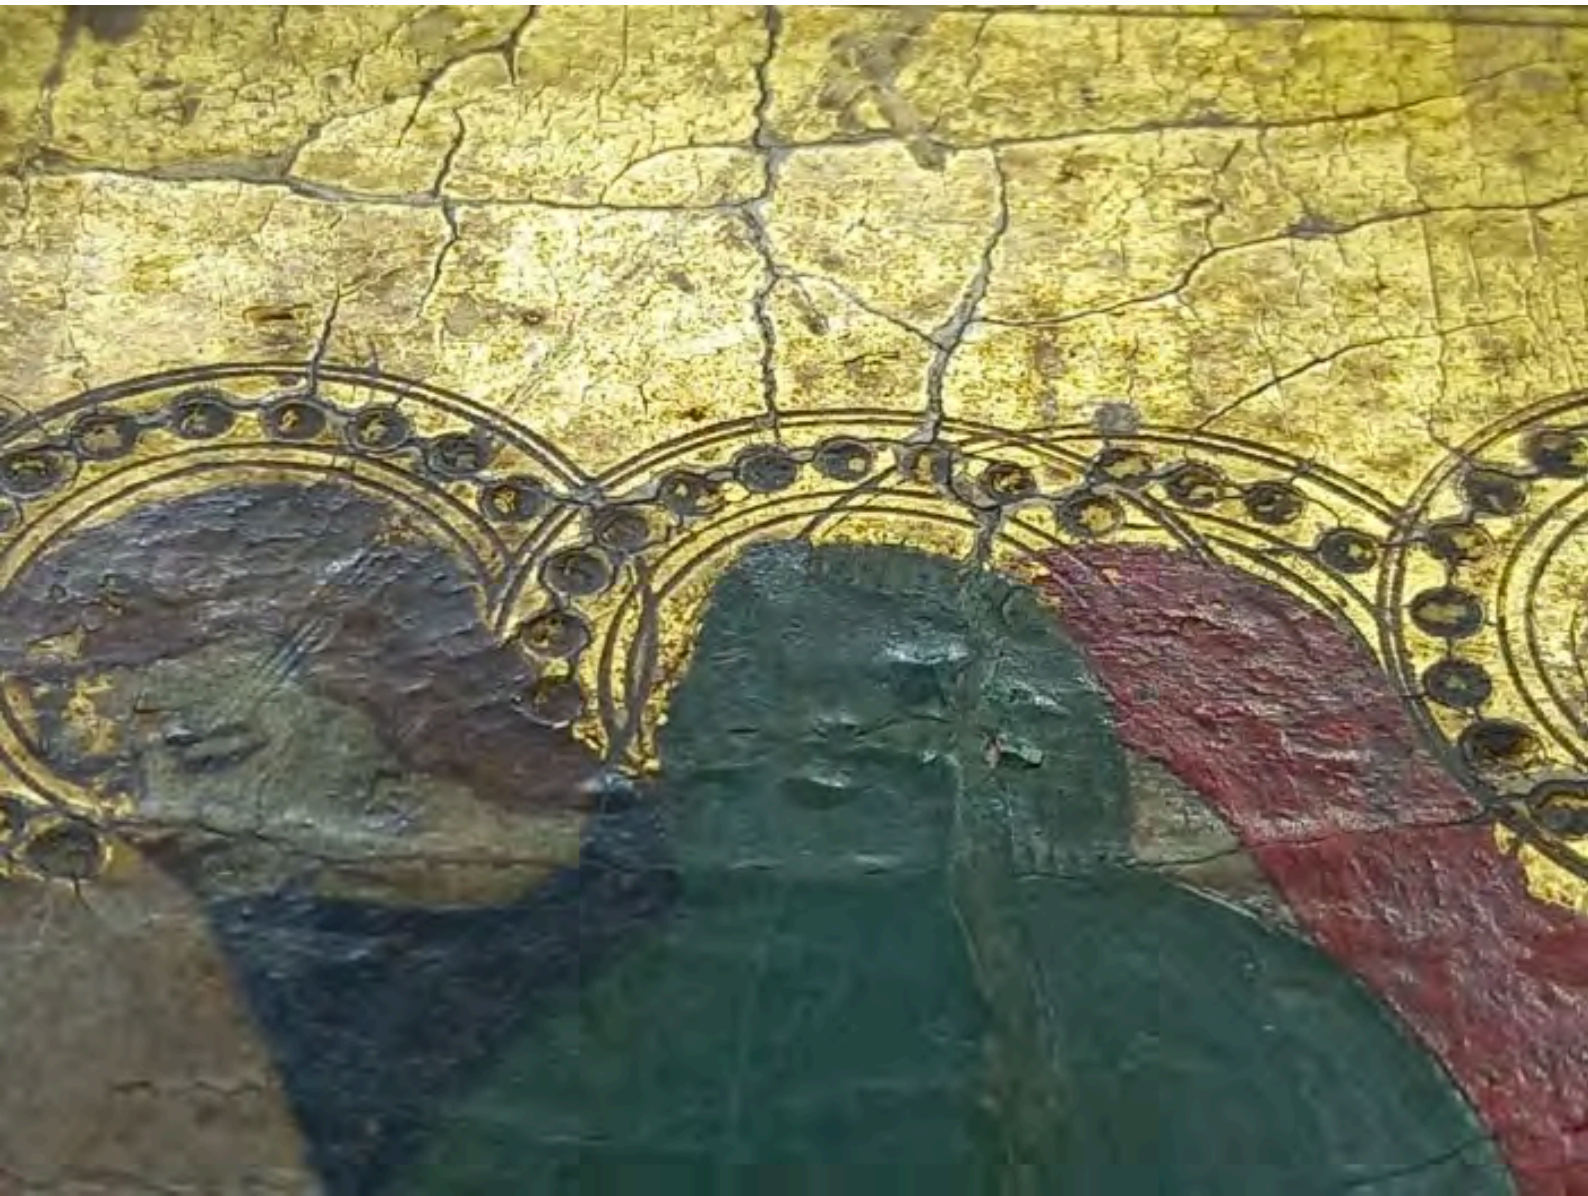
Lifting of paint film

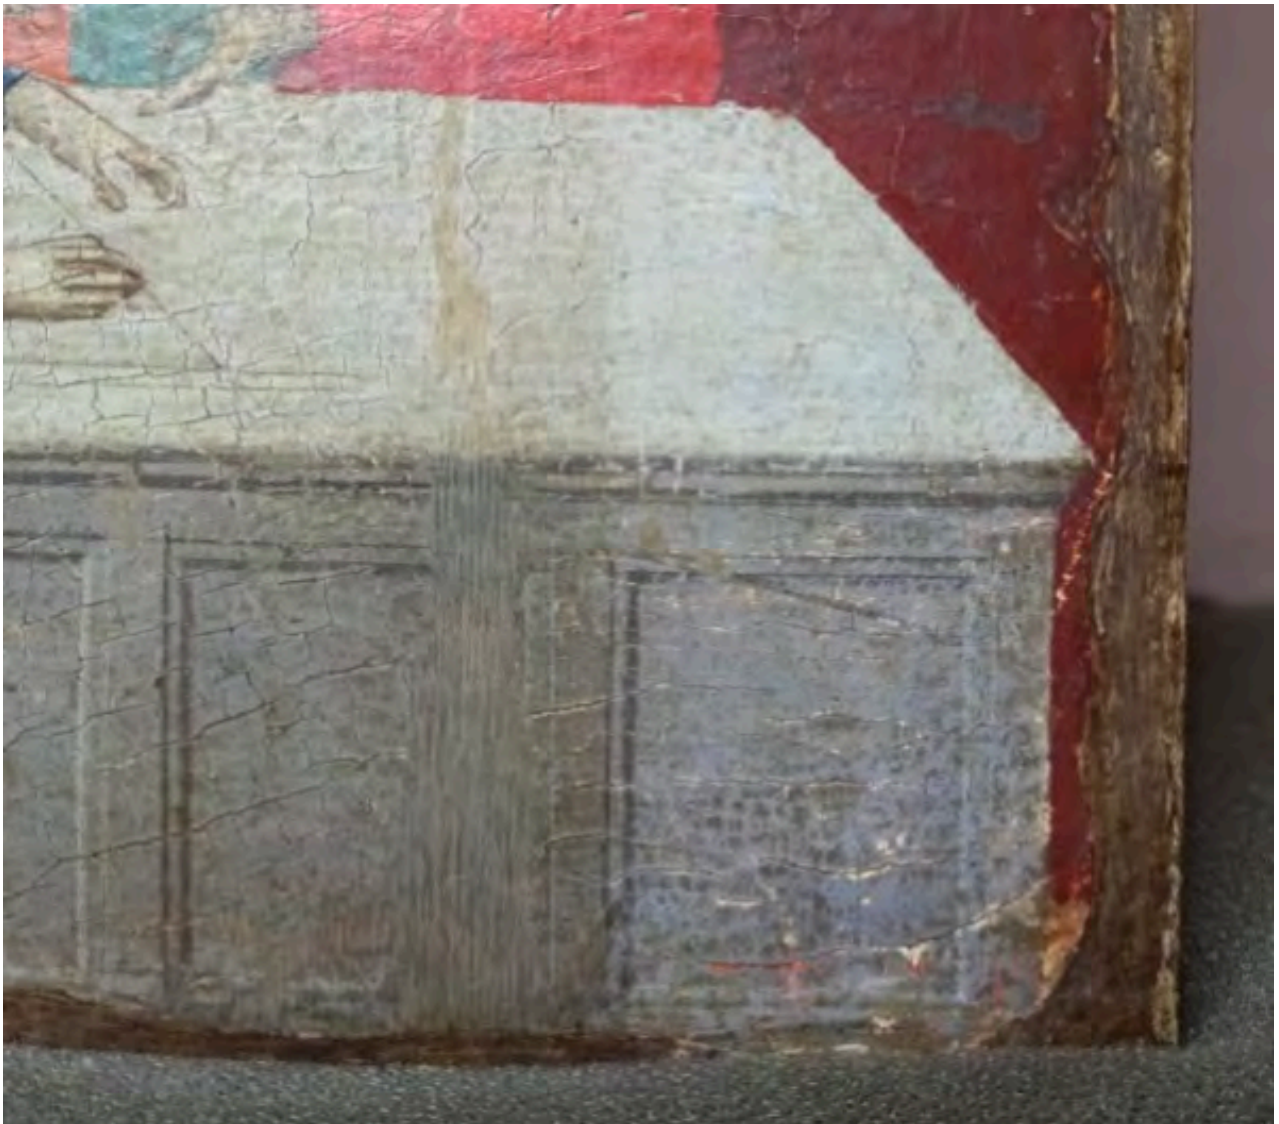
Removal of oxidised paint

The varnish from the previous restoration, now oxidized, was therefore removed by patching with a solvent mixture called 'Taco 7' (ethyl alcohol 45%, acetone 21%, petroleum ether 34%).

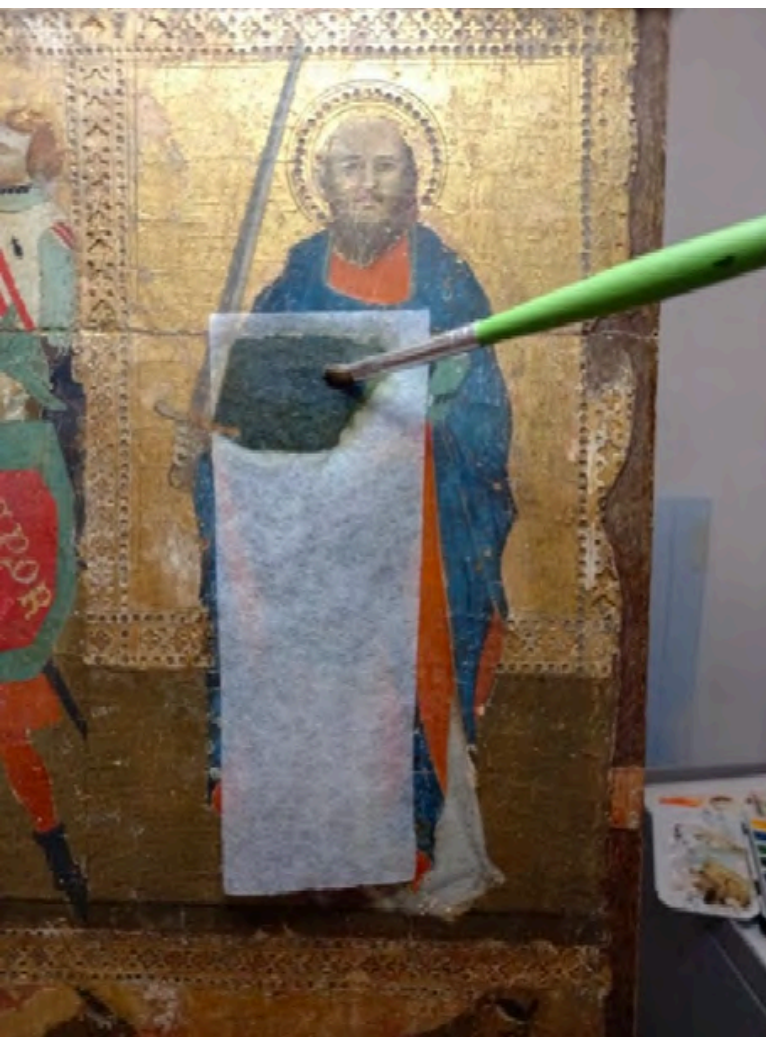
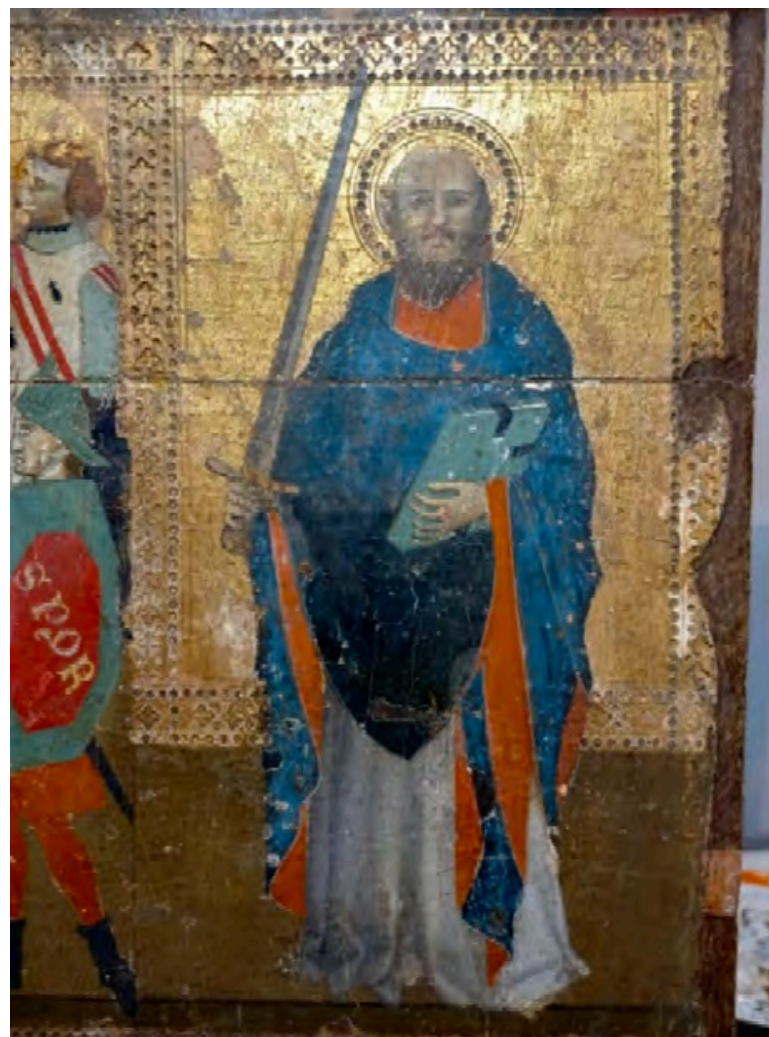
Blue drapery cleaning

A more thorough and localized cleaning was then carried out on only some of the paints by extraction with Japanese paper and application of a 10% solution of ammonia in water, which helped restore the original appearance of the blackened blue drapery.

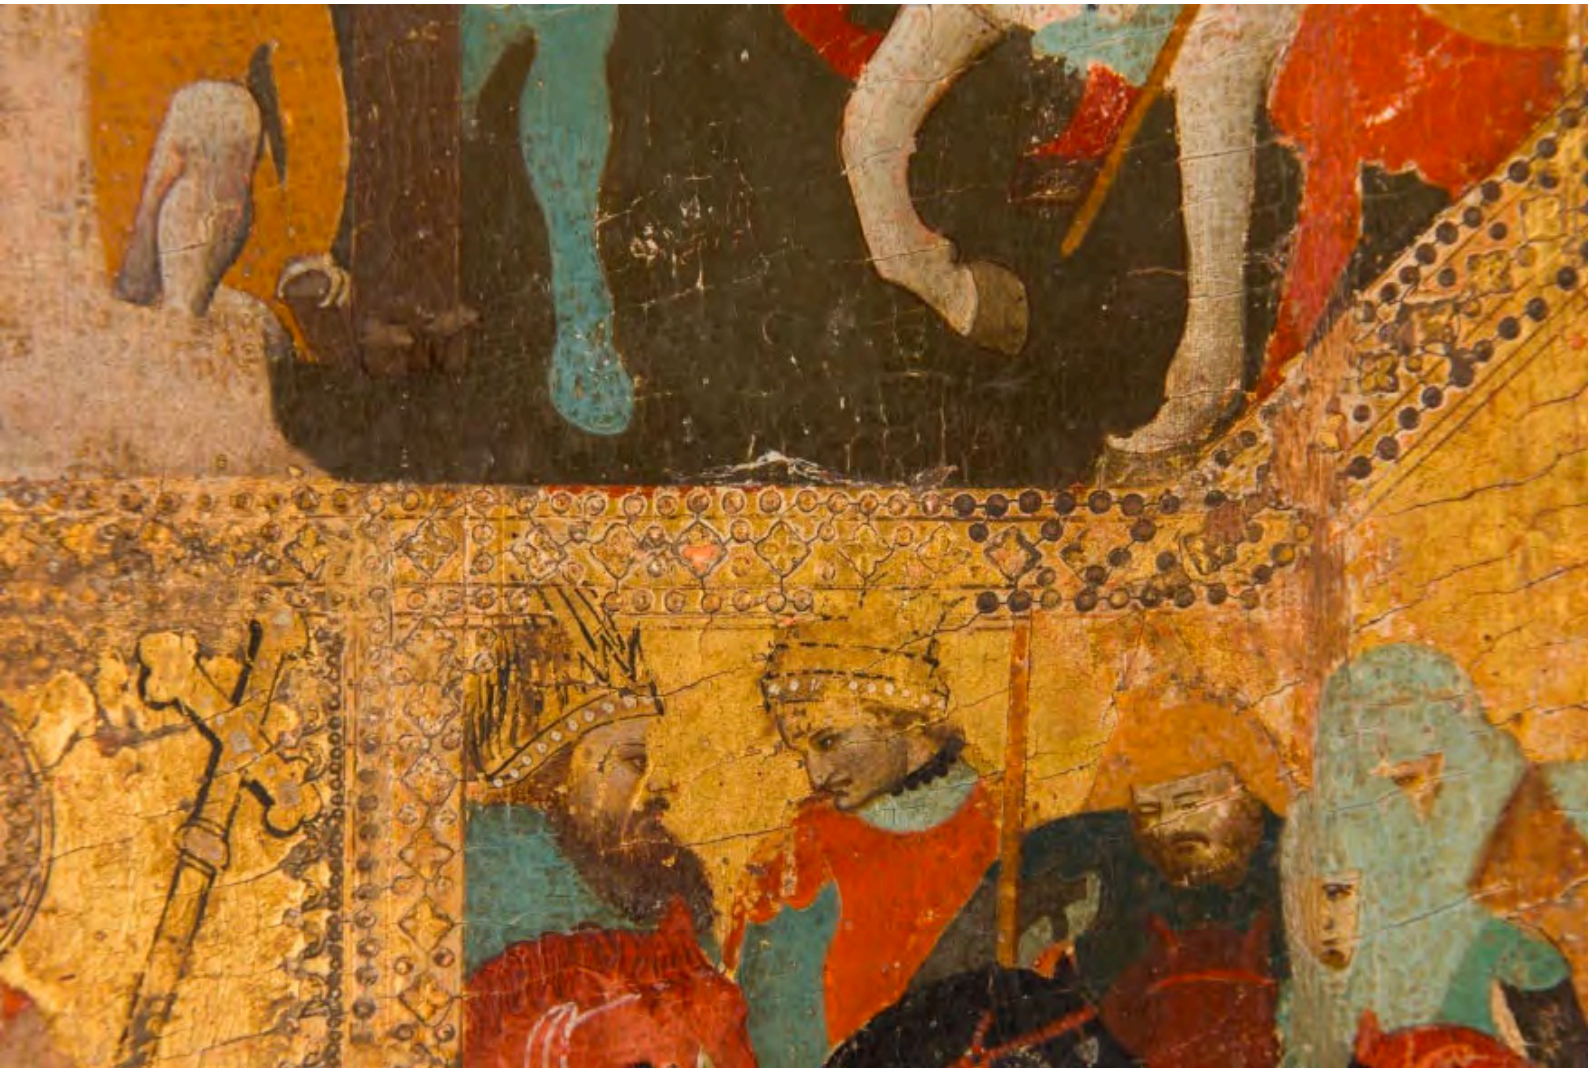
Punch cleaning

The rich punching of the gilding was also cleaned with various types of probes in each of the small recesses, thus recovering the original gilded surface of these recesses and restoring the brilliance of the work.

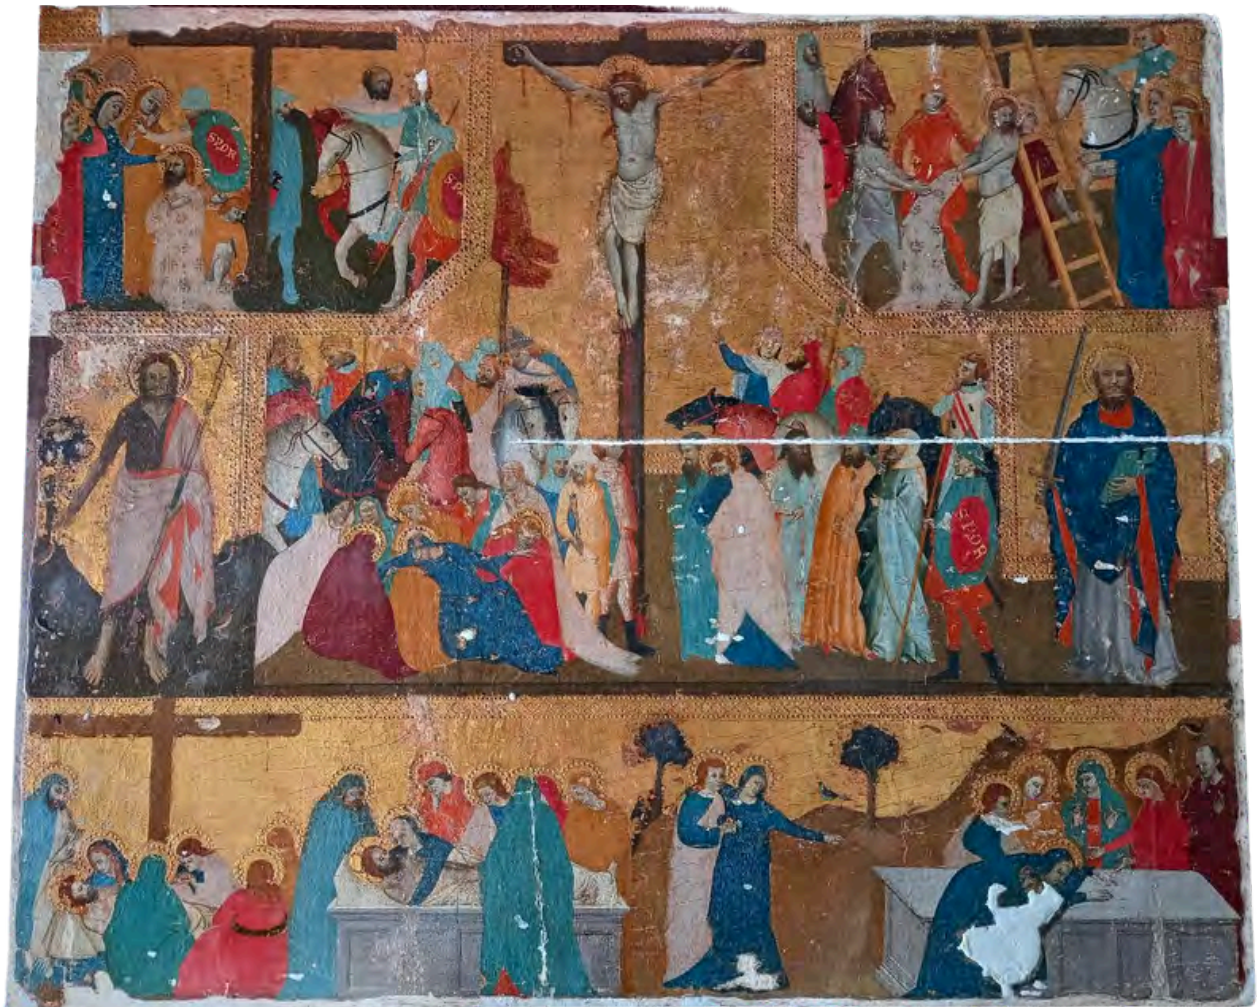
Execution of grouting once cleaning is complete

After a first coat of protective varnish, they filled the gaps in the preparatory layers with Gesso di Bologna and rabbit glue.
