# Compartment of a Predella with Episodes from the Life of the Virgin, Flight into Egypt

**FINAL RESTORATION REPORT  
JULY 2025**

# State of Preservation and Restoration Procedures

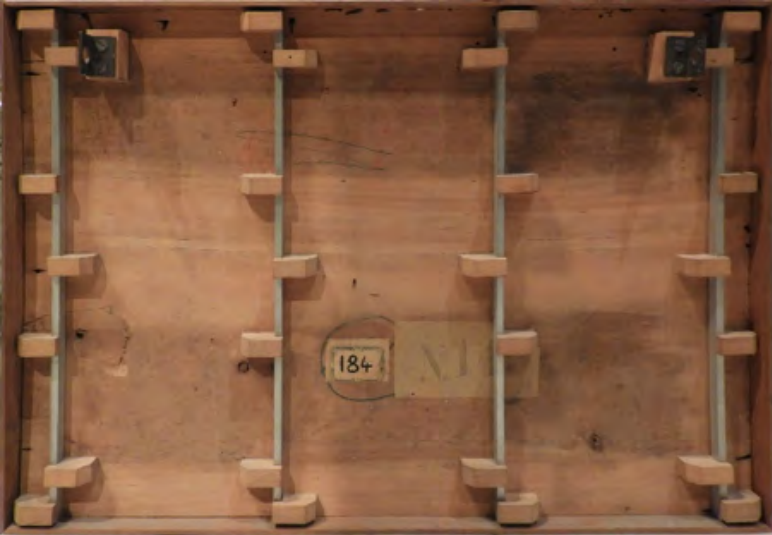
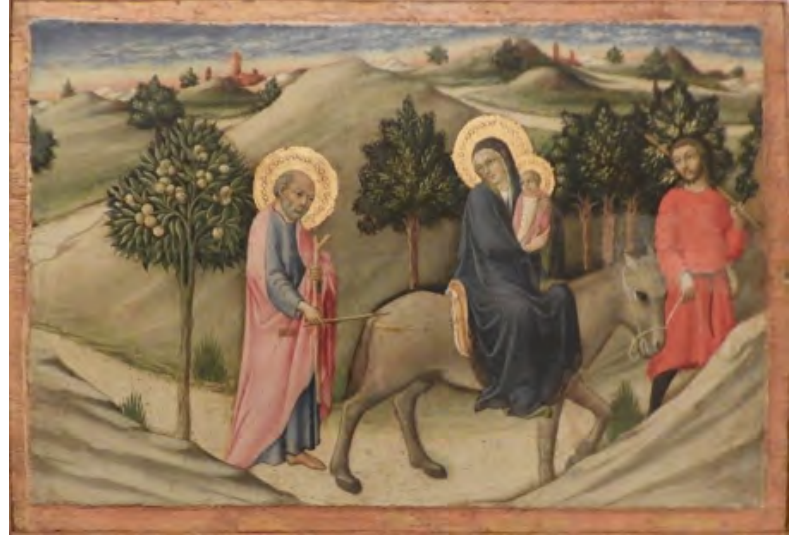
The work consists of a single poplar wood panel cut at an angle, and measures 33.2 x 49.7 cm with an average thickness of 5 mm **(photo 1)**. The plaster and animal glue preparation was presumably originally applied to the face of the board facing the core, later covered by a painting film. The board grain is horizontal to the pictorial representation. Along the entire perimeter of the recto of the painting, a portion of rough wood is visible, suggesting that the work was framed **(photo 2)**.

**Photos 1-2: Artwork back and front**

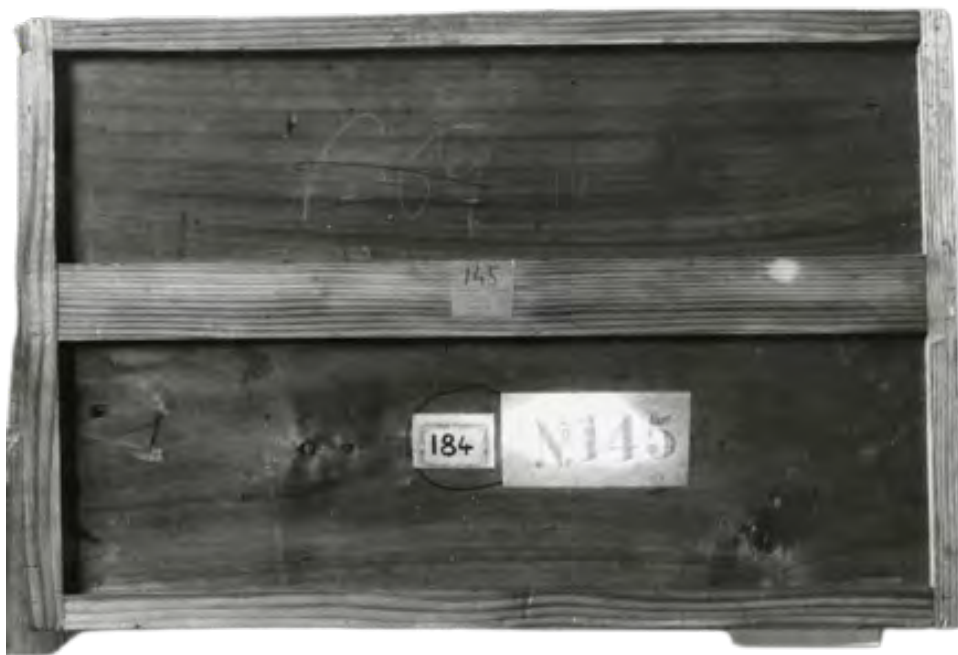
Analysis of archival documentation shows that the painting underwent several documented restorations between the 1960s and 1980s. An unsuitable containment system on the support, installed during an earlier, undated restoration between 1972 and 1973, was replaced. During this intervention, the artwork was thinned and reinforced with a framework, which caused it to warp and crack along its entire width. The result is a pictorial film lifting **(photo 3)**.

**Photo 3 - Archival photo of the framing before the 1972-73 intervention.**

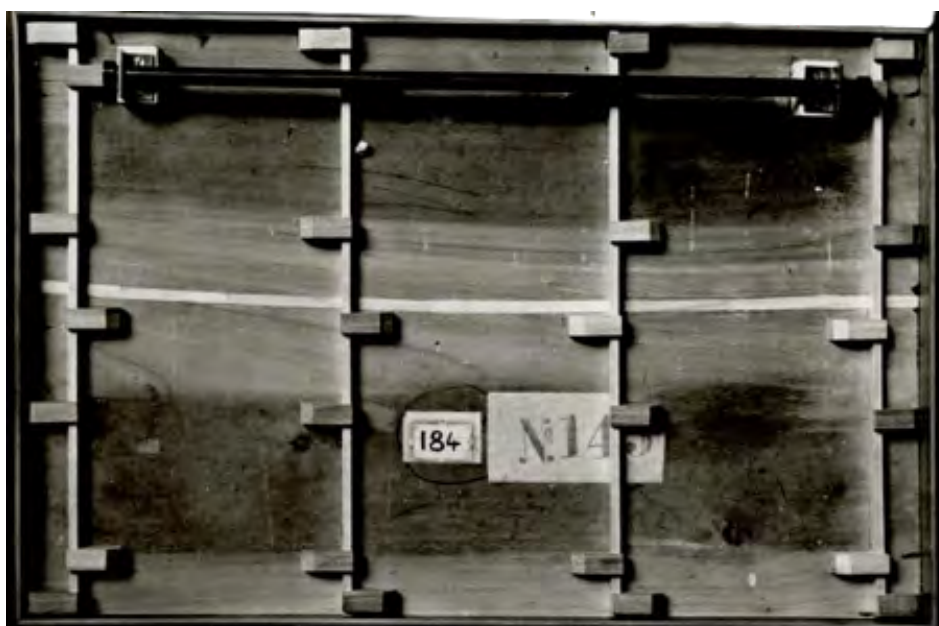
The ruler marks on the back of the board are still visible in this frame. During the restoration carried out in the 1970s by M. De Luca, the support was disinfected using formic aldehyde gas and chloronaphthalene, and then restored using wedges along the longitudinal cleft on the back. The previous framing was replaced with a parquetry made of four shaped aluminum movable rods attached to the support by alternating catches **(photo 4)**.

The support is currently in a fair state of preservation. The issues affecting the work are cracking and board buckling. Regarding the structural restoration of the longitudinal crack, the insufficient depth of the wedges did not prevent adhesion defects in the preparatory and pictorial layers from propagating. However, the 1970s restraint system no longer allows the wood to move naturally, as the movable aluminium bars are blocked, providing too rigid a constraint. Finally, the support is affected by slight, inactive entomological damage, evidenced by galleries and exit holes of wood-boring insects.

**Photo 4 - Archival photo of the restoration parquetry performed in 1972-73**

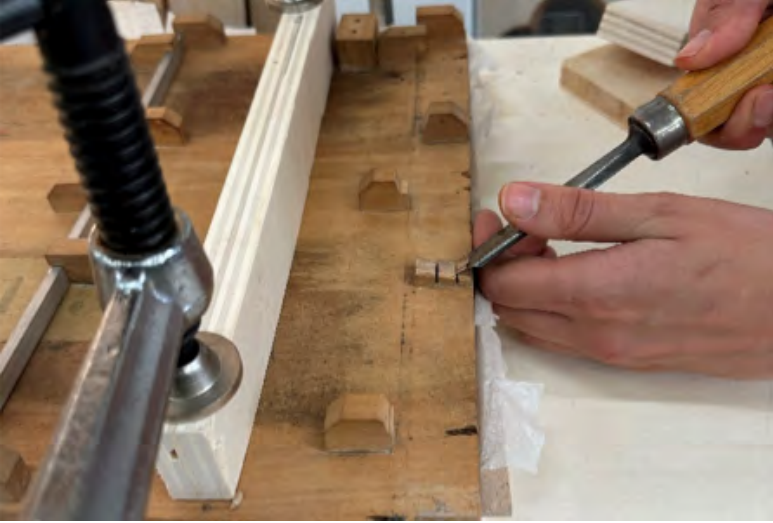
**Photo 5 - Removal of previous parquetry**

Before working on the support, the restorer protected the pictor with a glaze made with 12% Klucel G, and, after the anoxic treatment, freed the artwork from the old parquetry **(photo 5)** and constrained using pressers on a shaped base to restrict its movement during the different restoration operations **(photo 6)**.

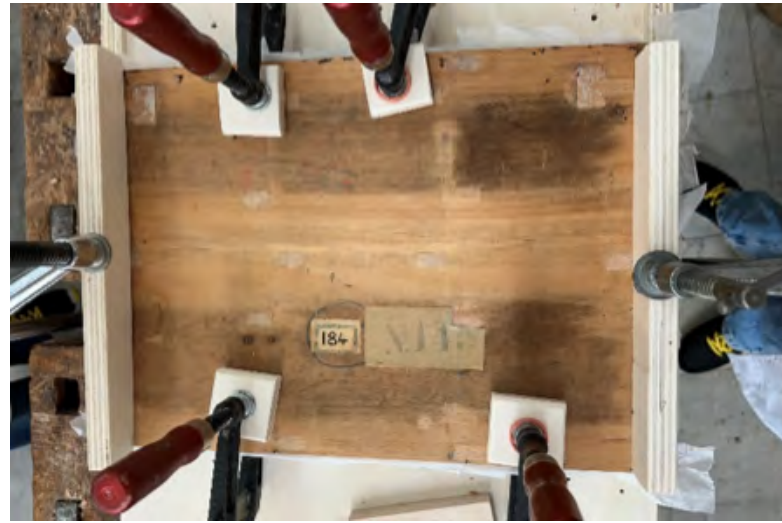
**Photo 6 - Checking the substrate using pressers and shaped base**

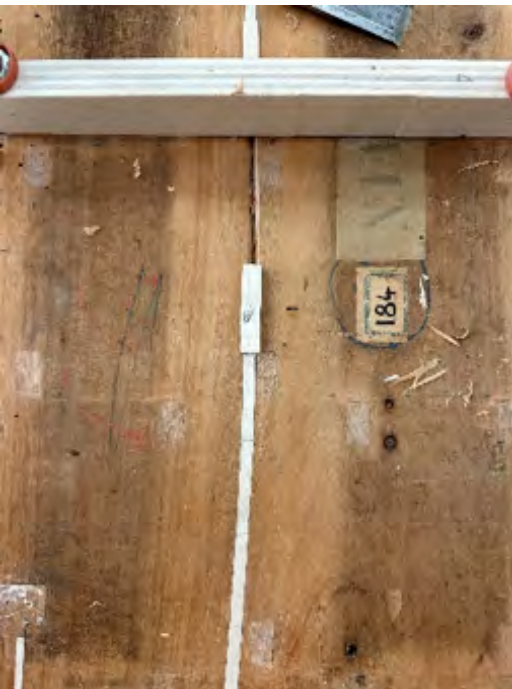
**Photo 7 - Replacing the previous restoration**

The previous structural restoration was then removed and replaced by inserting deeper wedges into the back. The restorer made the new wedge housings using chisels along the course of the longitudinal fissure **(photo 7)**.

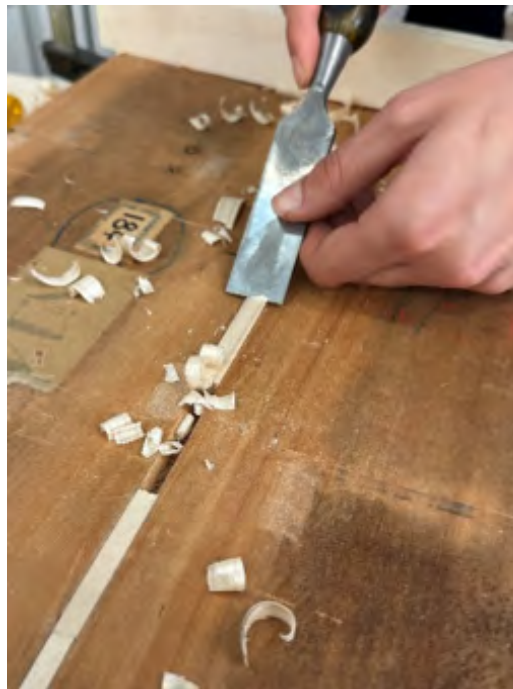
**Photo 8 - Machining of the restoration wedges**

Once shaped, the inserts were glued using a polyvinyl acetate-based adhesive (Vinavil® NPC White Star) mixed with wood powder, and then placed under appropriate pressers. Once the glue had set, the restorations were planed level and chromatically tuned by water-etching **(photos 8 - 9)**.

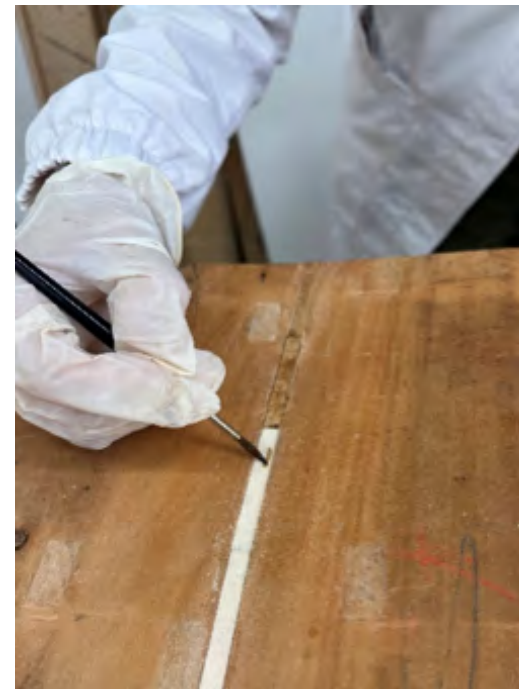
**Photo 9 - Etching the wedges**

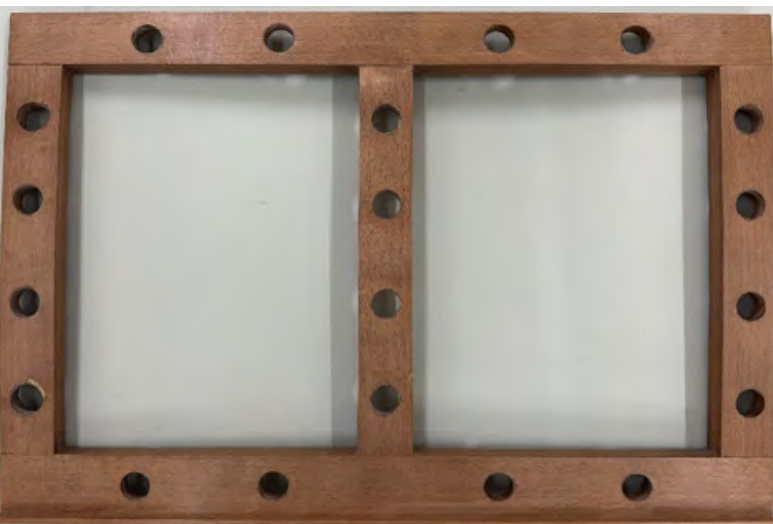
**Photo 10 - Perimeter frame with center crossbeam and support base for the new containment system**

The restorer designed a spring restraint system to control the movements of the support, given the new display modes (climabox), consisting of a perimeter frame with a central crossbeam and support base **(photo 10)**, made from beech wood by assembling four laminates with a total thickness of 2 cm, following the embankment of the original support. The restorer finished the frame with a coat of dewaxed shellac and microcrystalline wax.

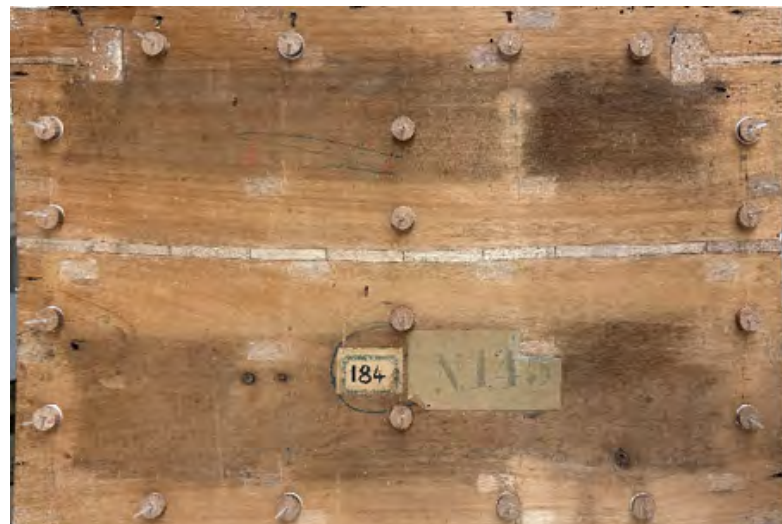
**Photo 11 - Bonding the wooden bases with nylon threaded screws**

The restraining frame was secured to the painting with twenty disc springs and nylon threaded rods after obtaining the housings for the elastic restraints. These were then connected to the support using a small, circular wooden base glued on with polyvinyl acetate glue **(photo 11)**.

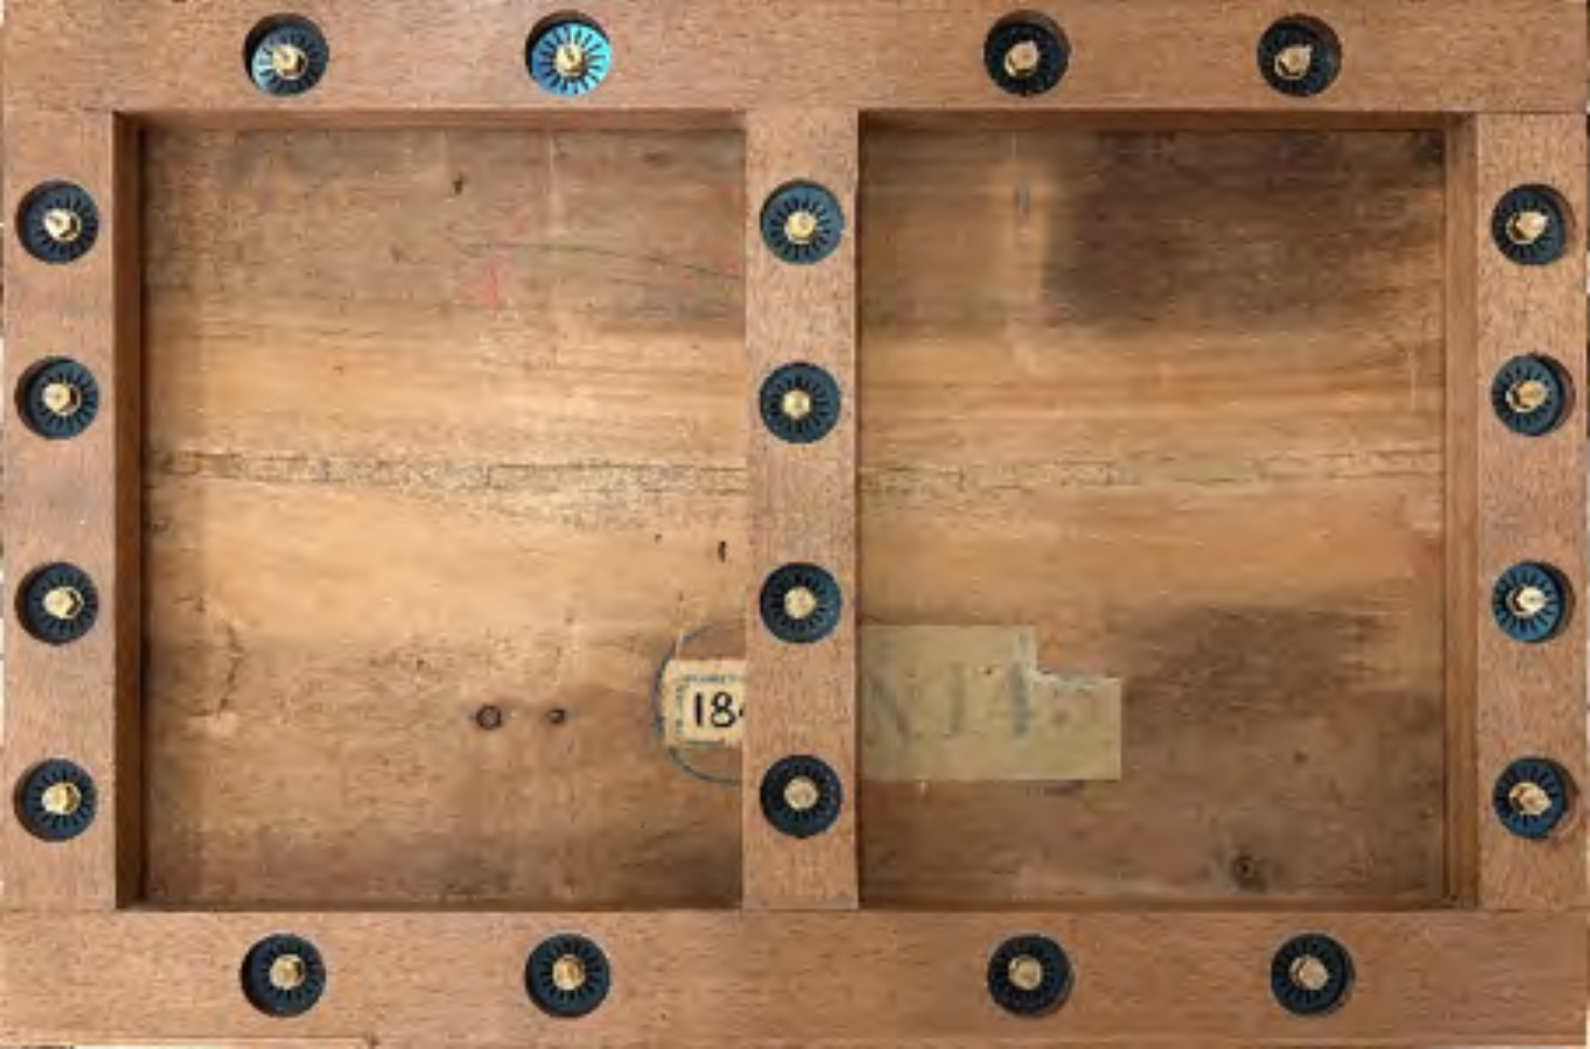
**Photo 12 - implementation of the elastic containment system**

The newly implemented elastic system **(photo 12)** enables the support's natural hygroscopic movements related to changing thermo-igrometric parameters to be contained.

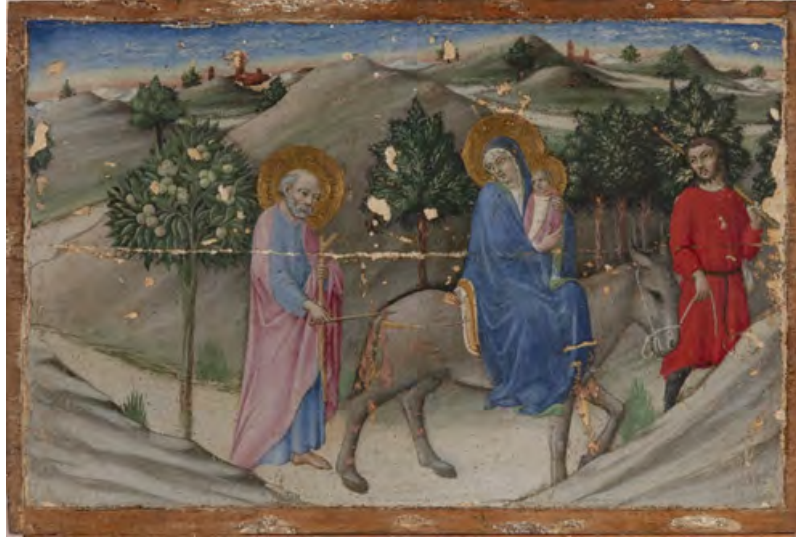
**Cleaning and removal of old grout**

Following initial cleaning tests, the restorer proceeded to completely remove the paints, glues, and old retouches dating back to the 1970s using mixtures suitable for the overlying substances. These included Taco 8 (used to remove various types of varnish) and Coccocollagen, which has a cleansing action and an intense impact on protein materials such as animal glues. Next, the restorer removed the fillers from the paint film and wooden support.

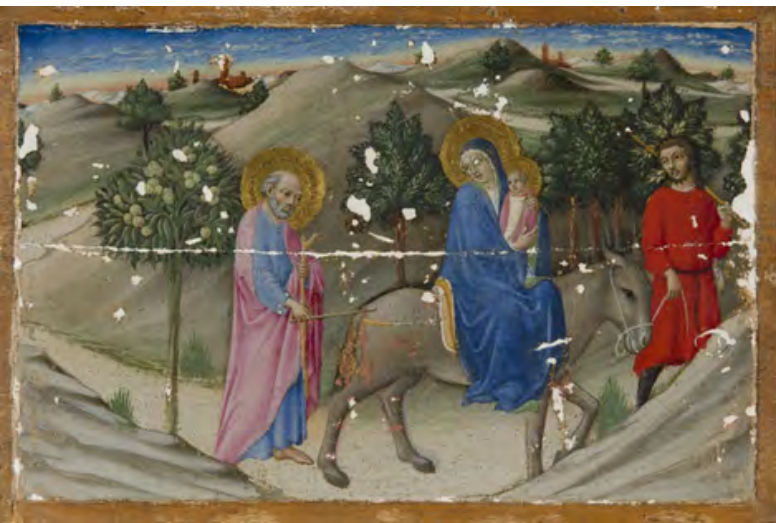
**New grout**

Afterward, the restorer gave a light varnish (Retoucher varnish dissolved in Petroleum at a ratio of 1:1) to protect it from the subsequent repair work on the gaps in the painted surface, using a mestica composed of Bologna chalk and rabbit glue.

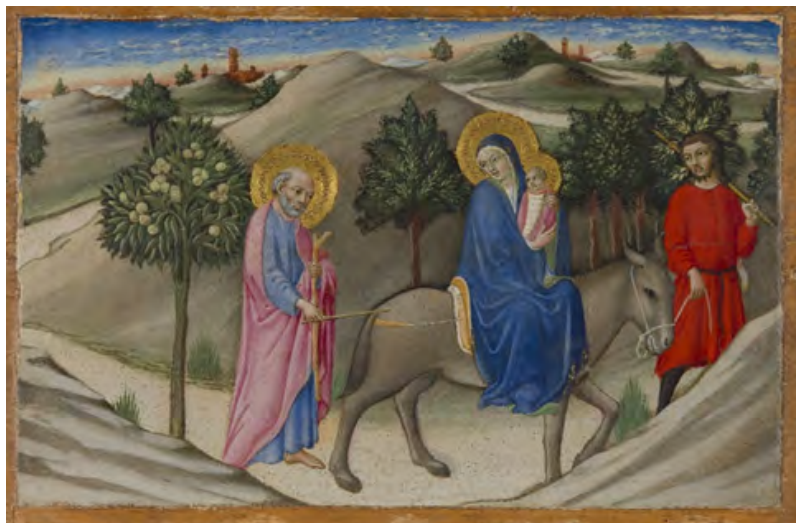
**Retouched board**

After smoothing the new grout, the restorer applied a second coat of diluted retoucher varnish to create homogeneous color fields ready for retouching with watercolor paints and varnish.

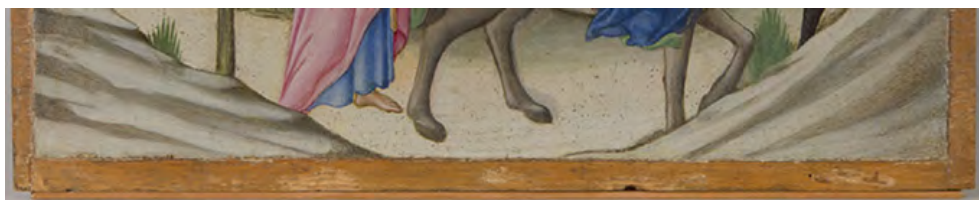
**support injury**

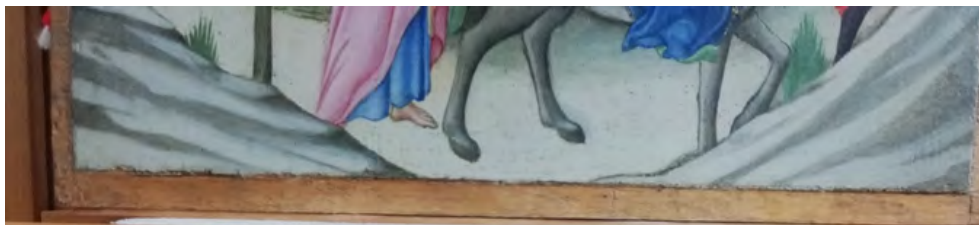
**Detail of restoring with wax**

The woodworm holes and wood injuries have been repaired using solid wax.

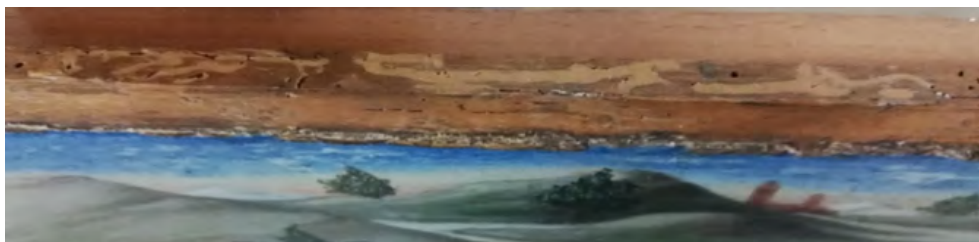
**Repair woodworm holes with wax**
