Ducal Hall in the Apostolic Palace

**ONGOING RESTORATION REPORT
FEBRUARY 2024**

Restoration of the paintings of the vault, lunettes, frieze, and Bernini curtains

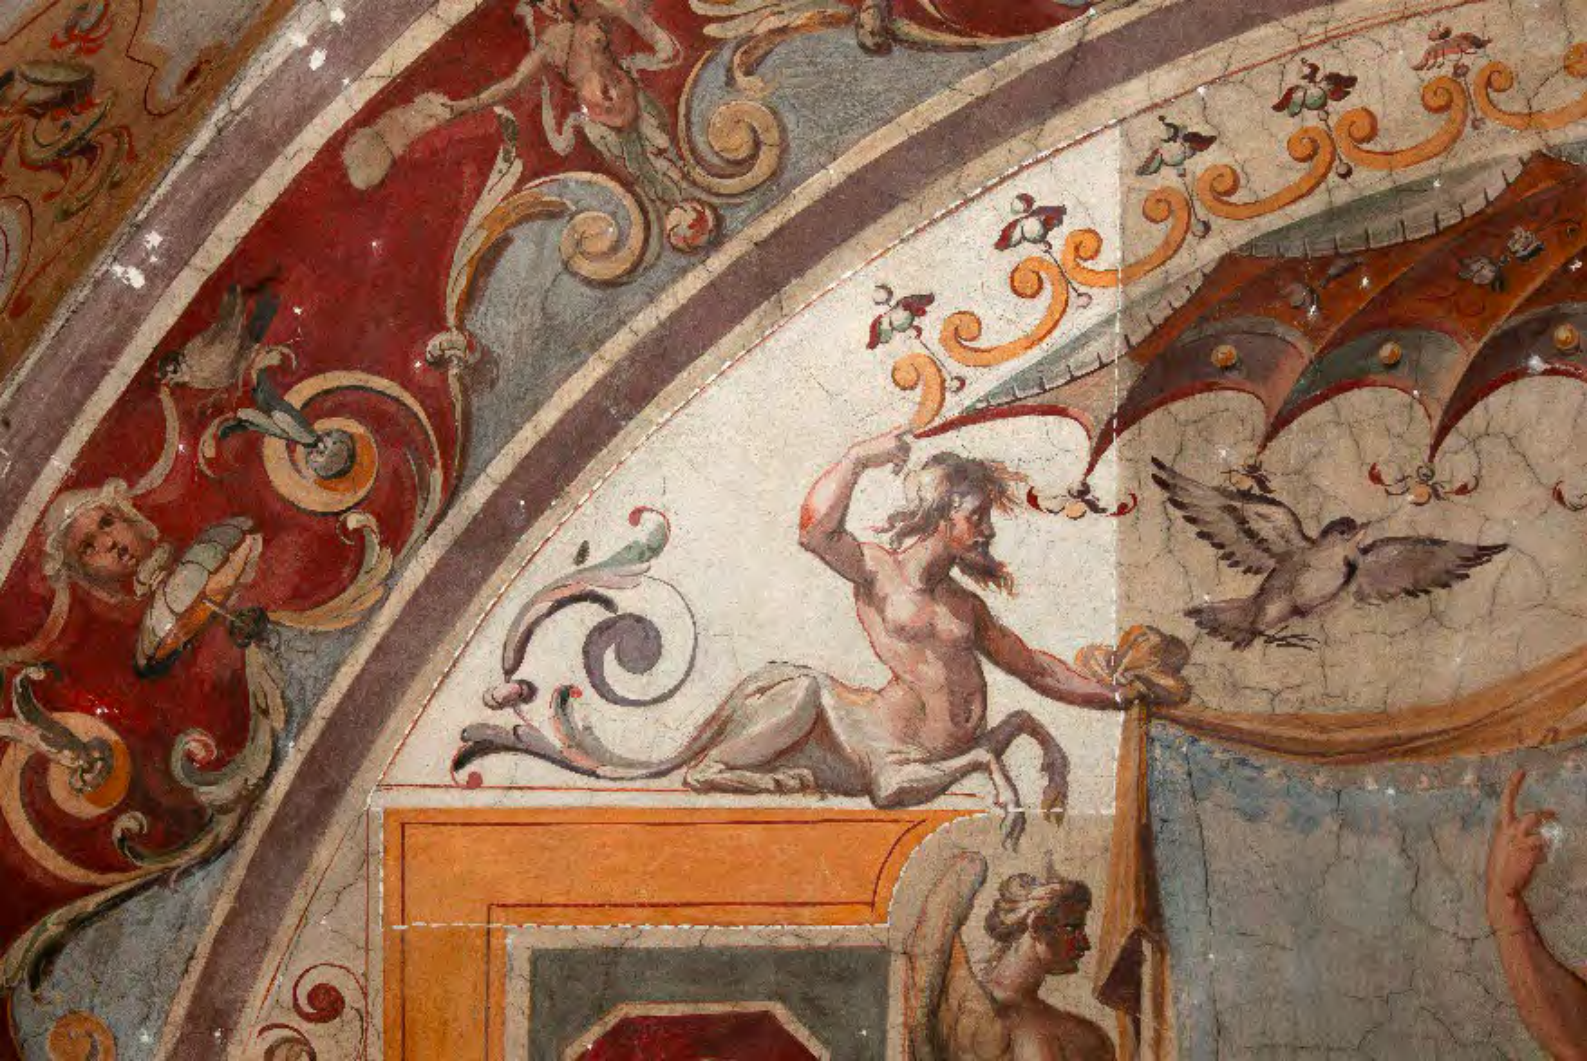
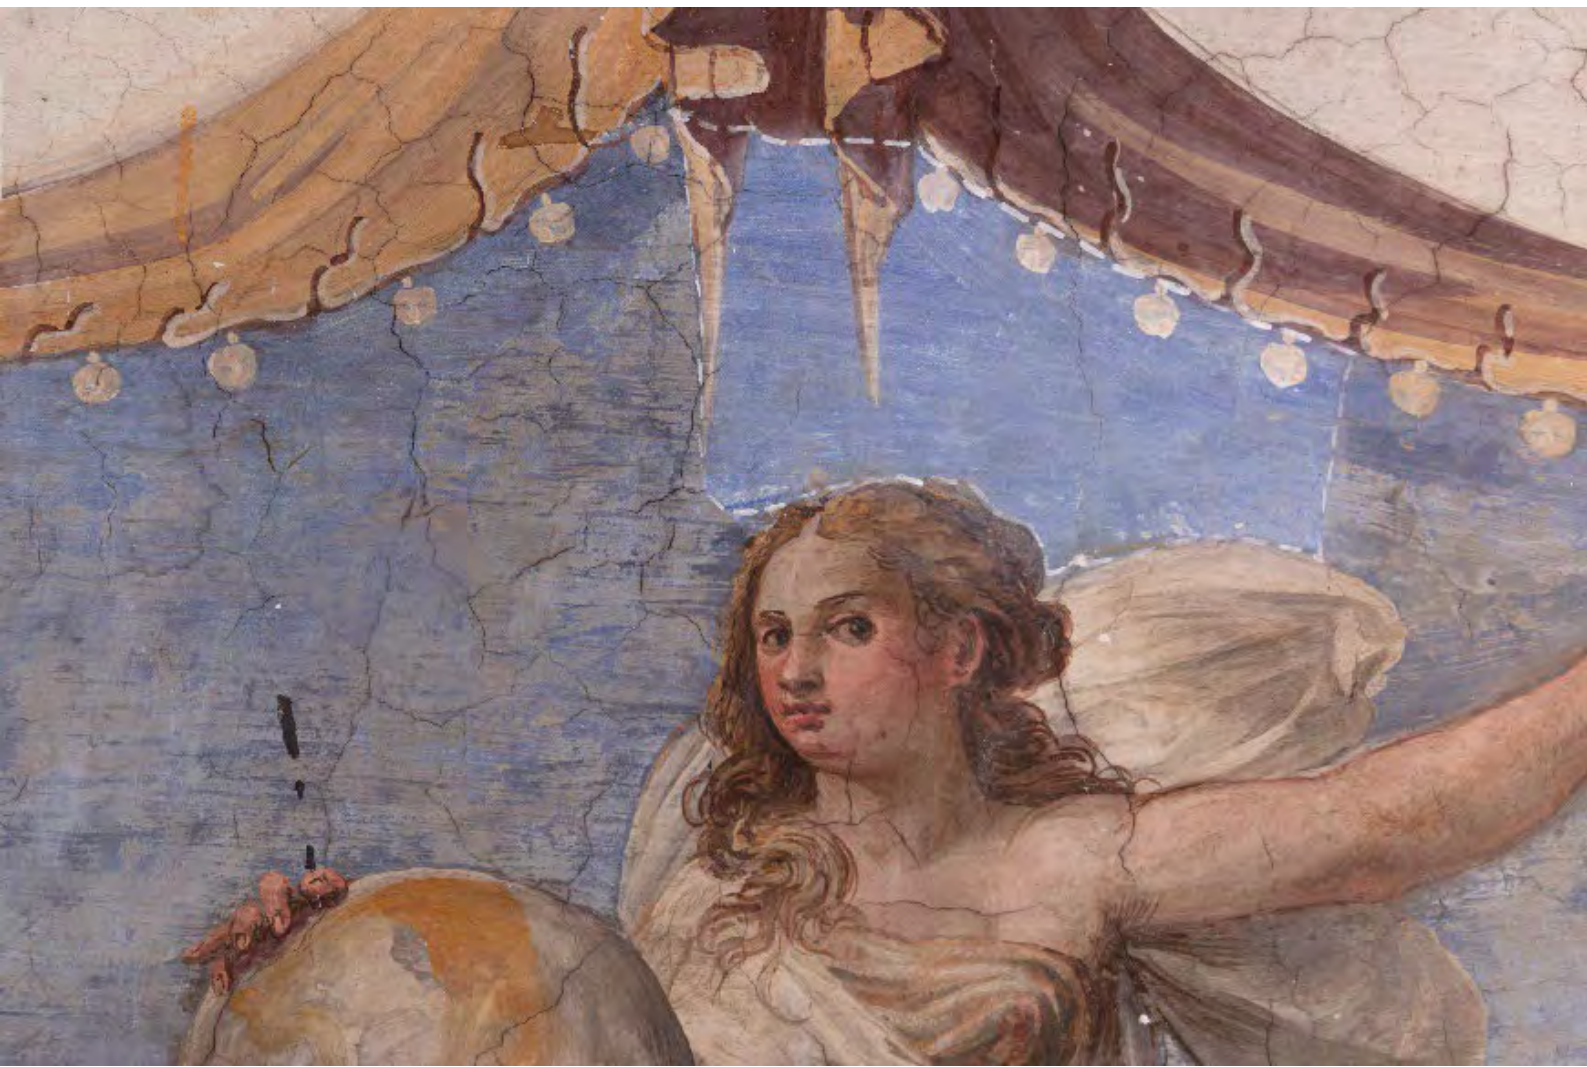
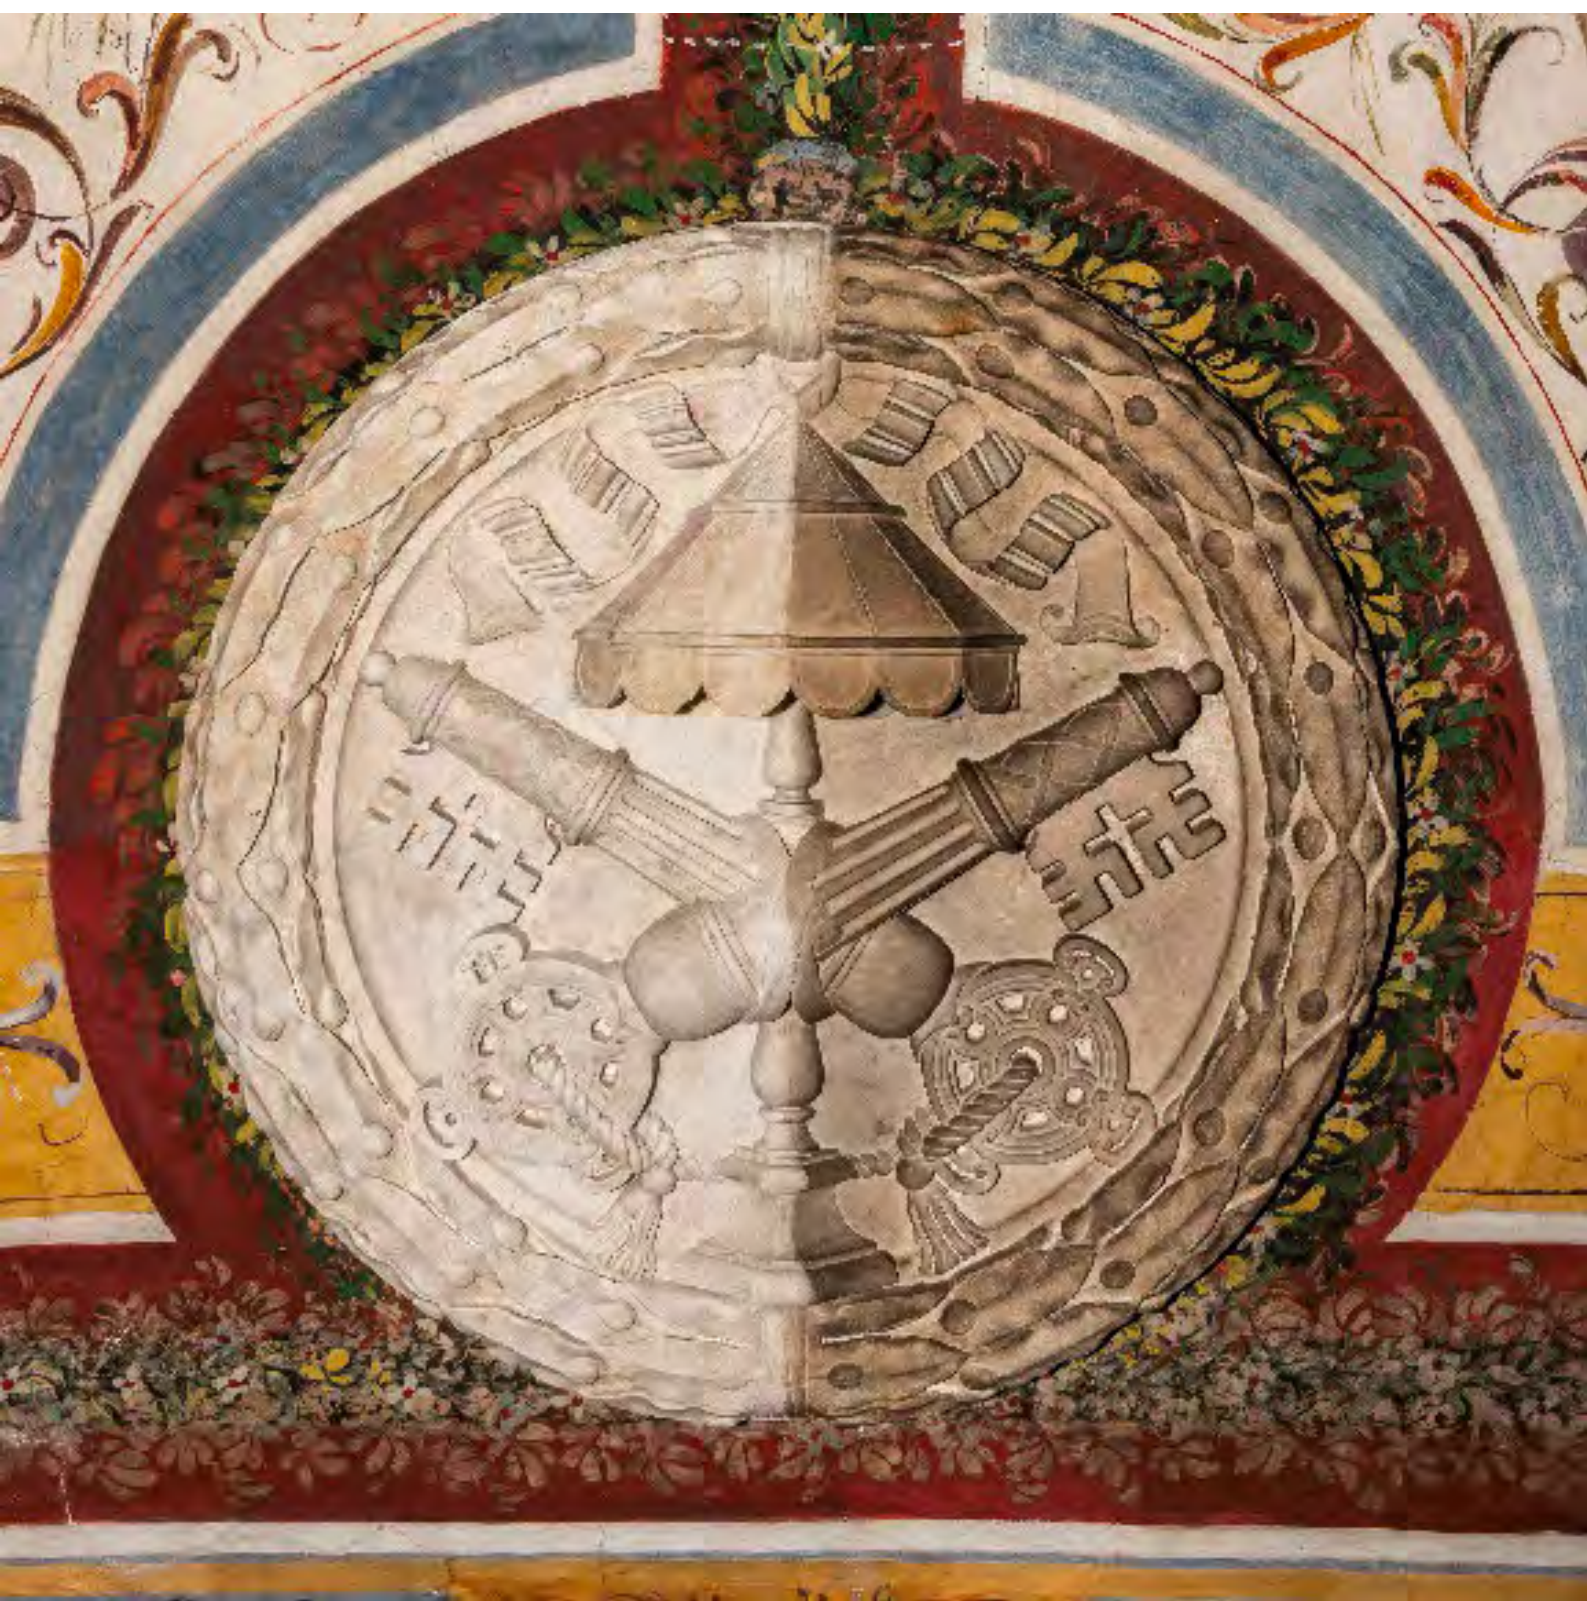
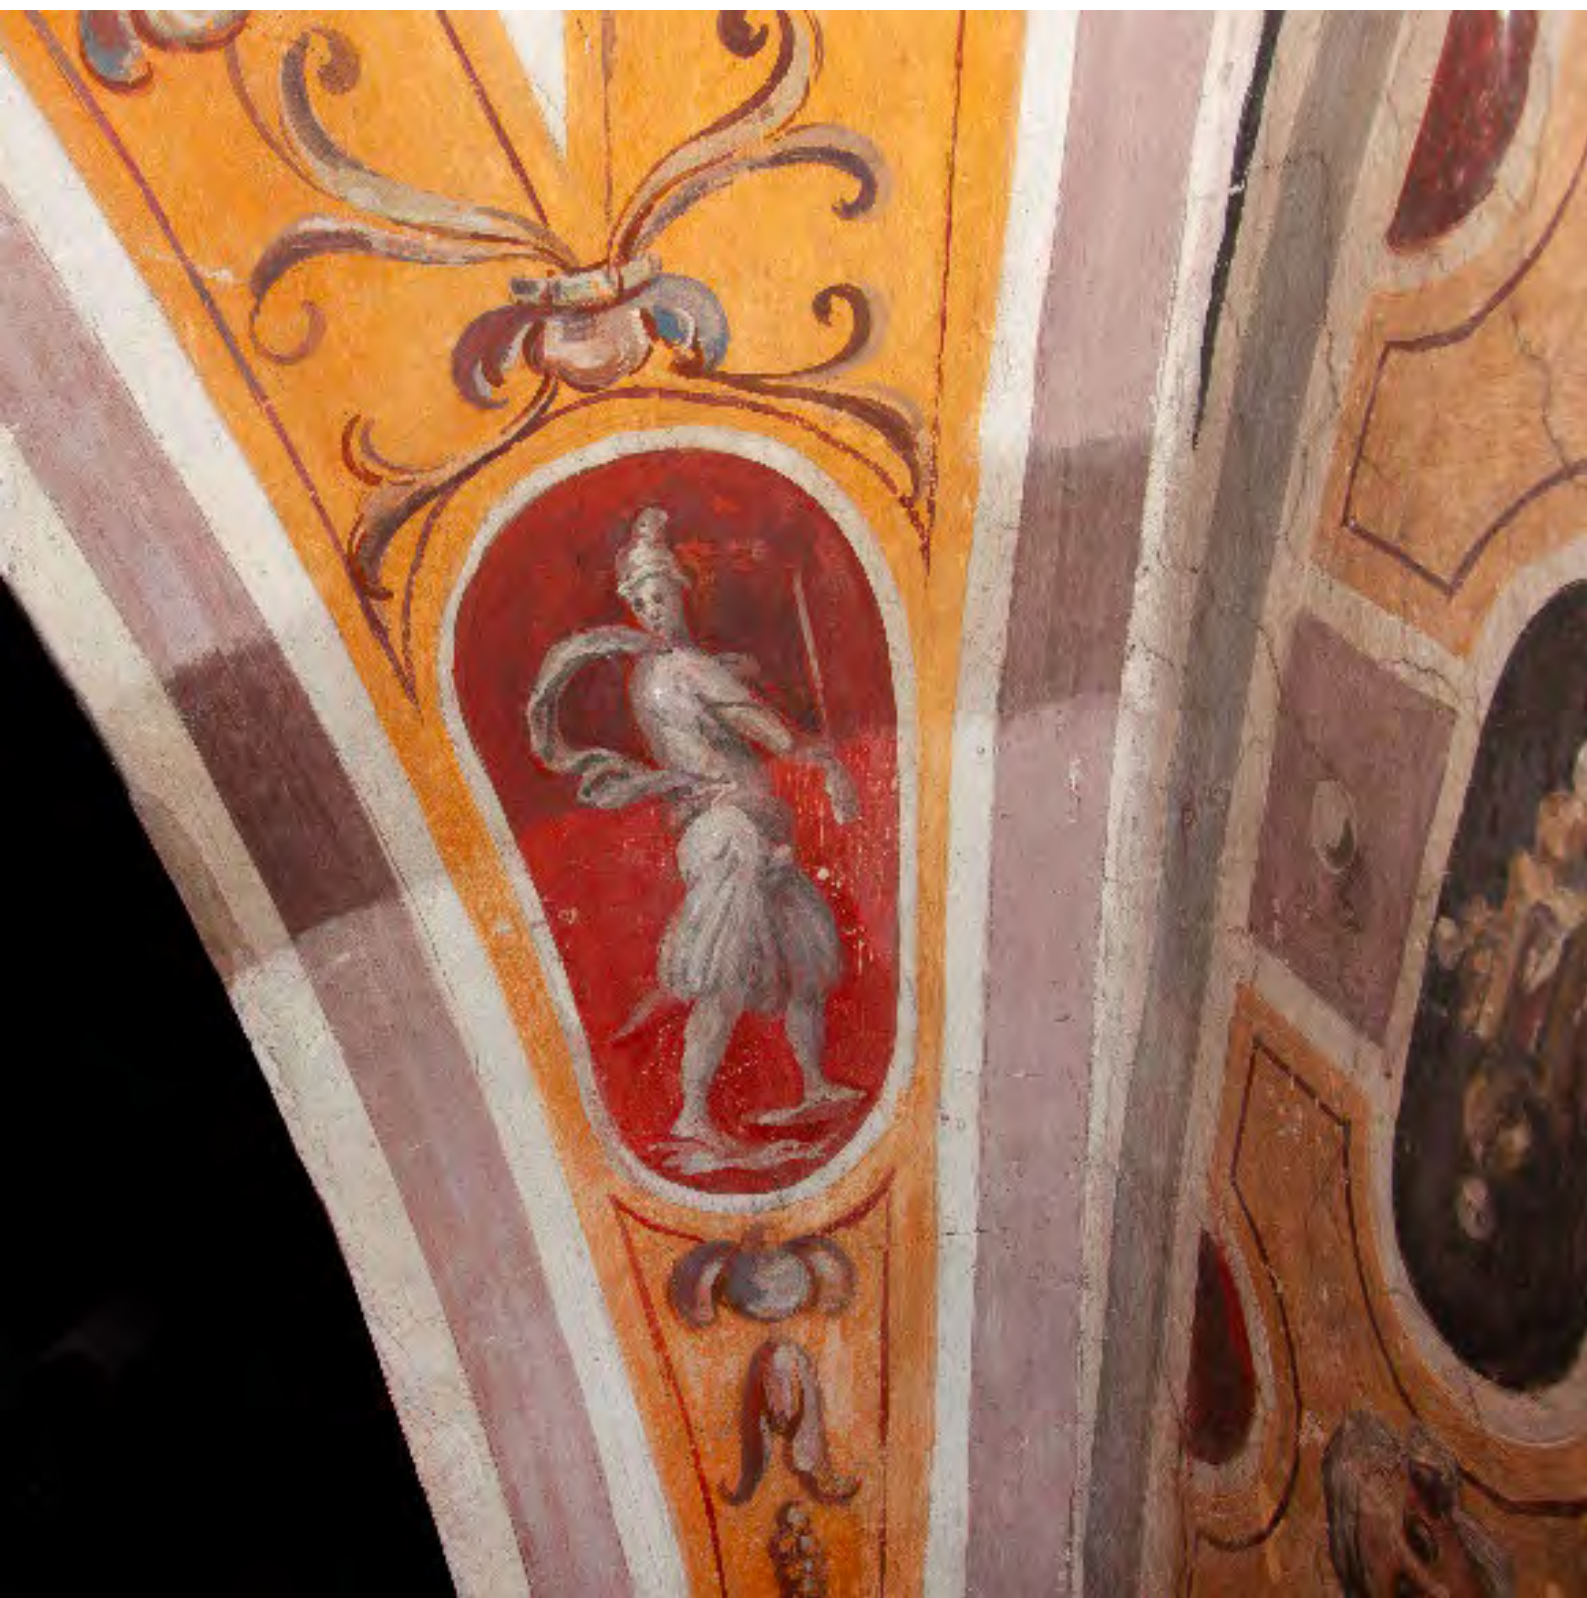
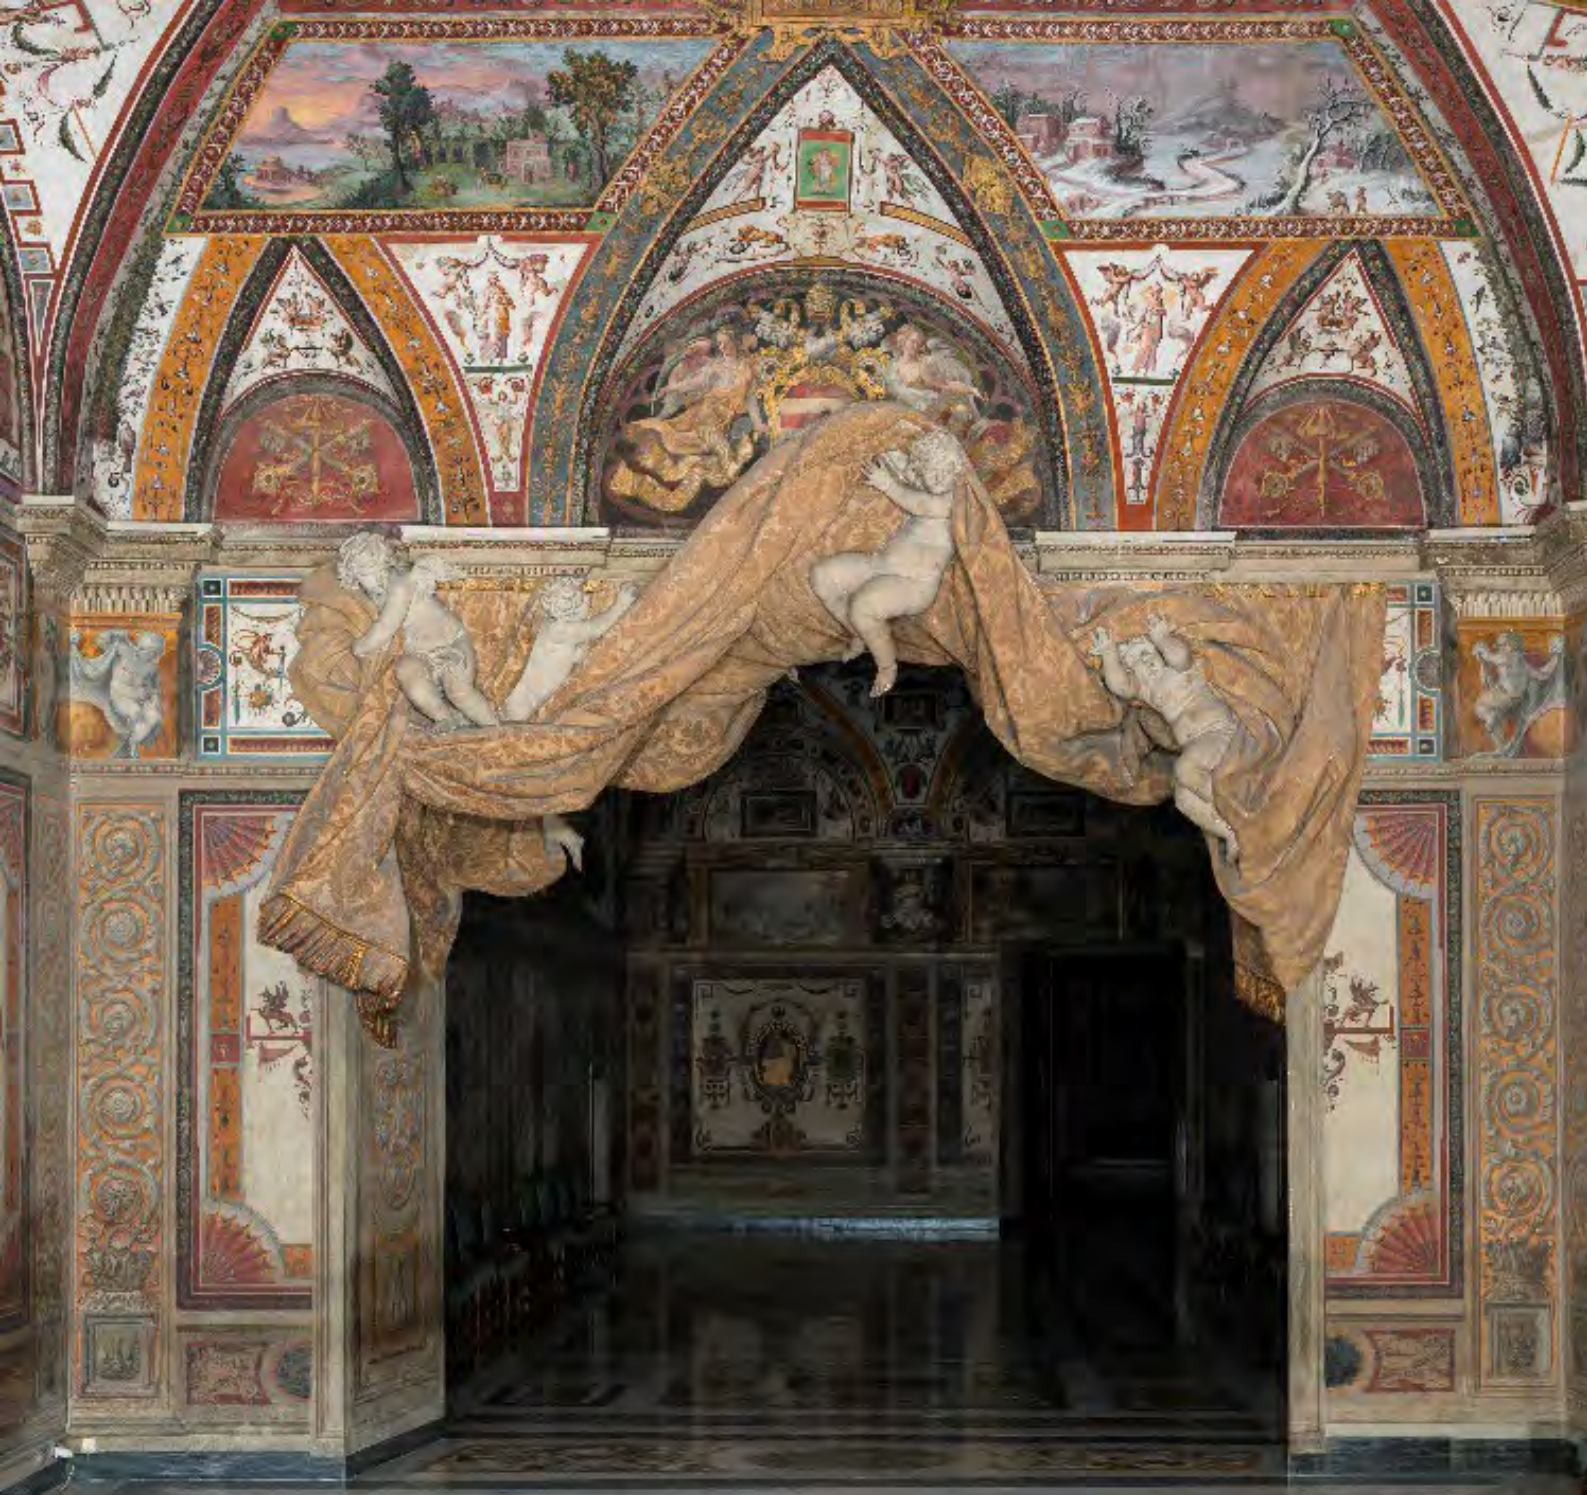
Current state of the Bernini curtain

From April until early August 2023, restorers performed depth consolidations of the Bernini drapery and carried out additional cleaning tessellations to better study the older painted layers. By comparing the tessellations with the eighteenth-century engraving showing the original design of the curtain with the arms of Alexander VII, it was found that the painting matched the ancient design.

The restorers made a rendering to understand how the drapery, currently chromatically linked to the walls from the 1900s, was instead anciently connected to the paintings of the Aula Secunda and Aula Tertia Vaults.

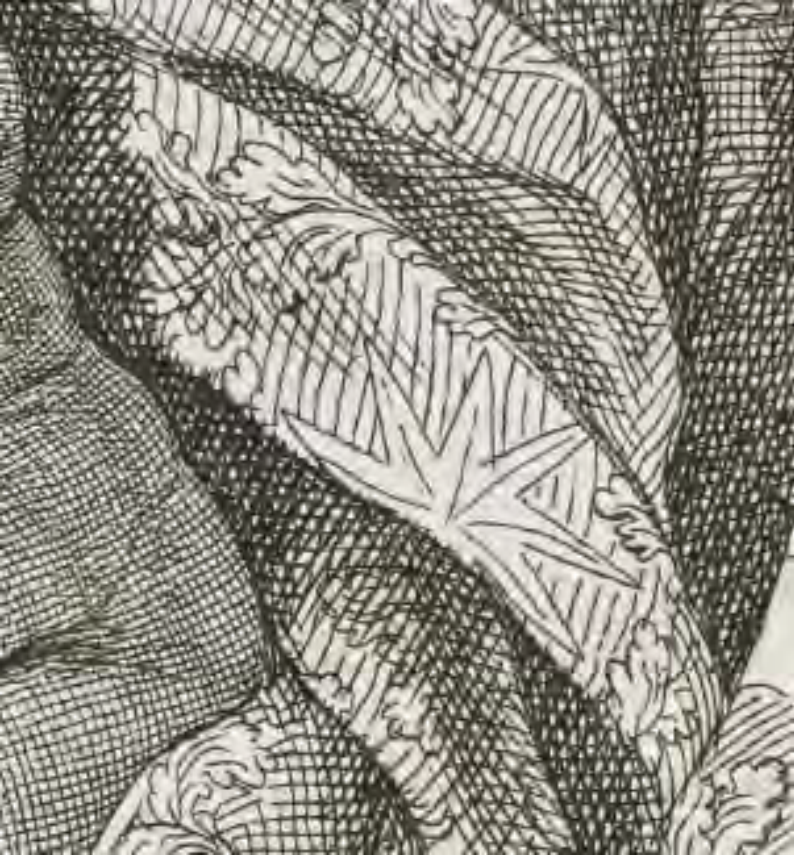
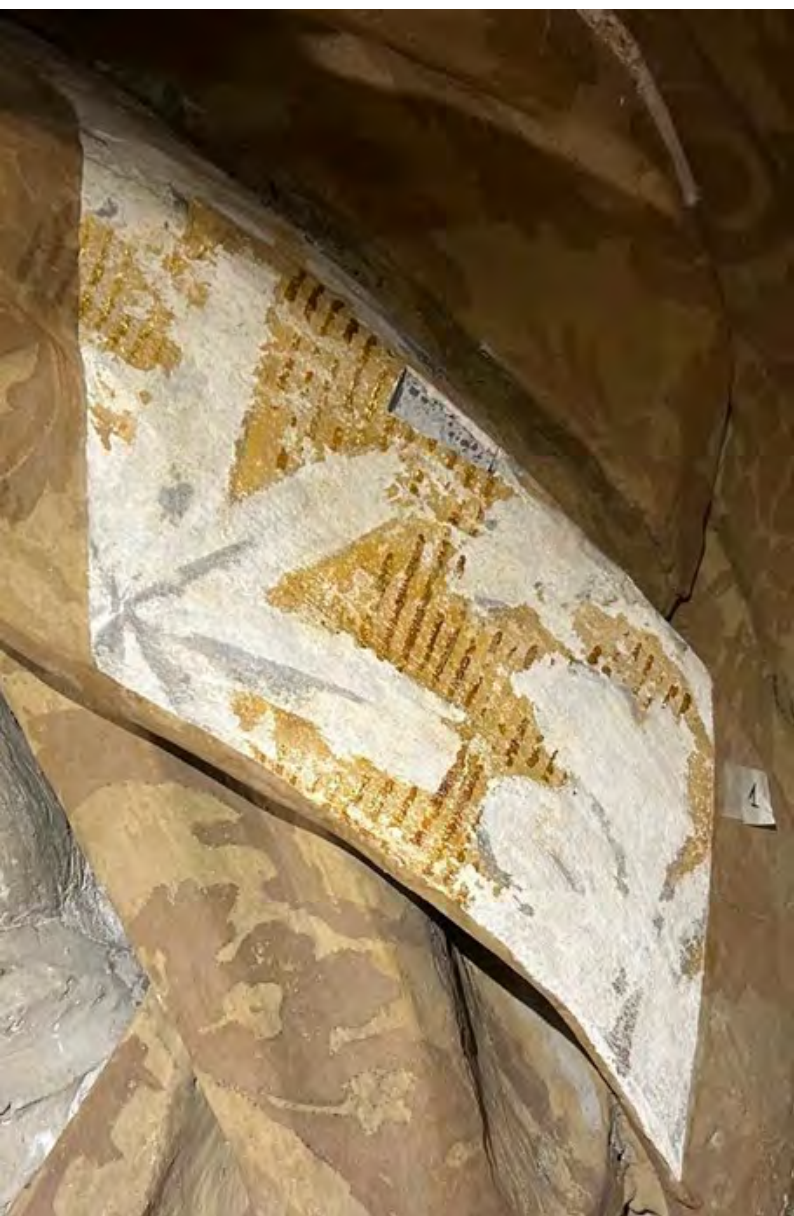
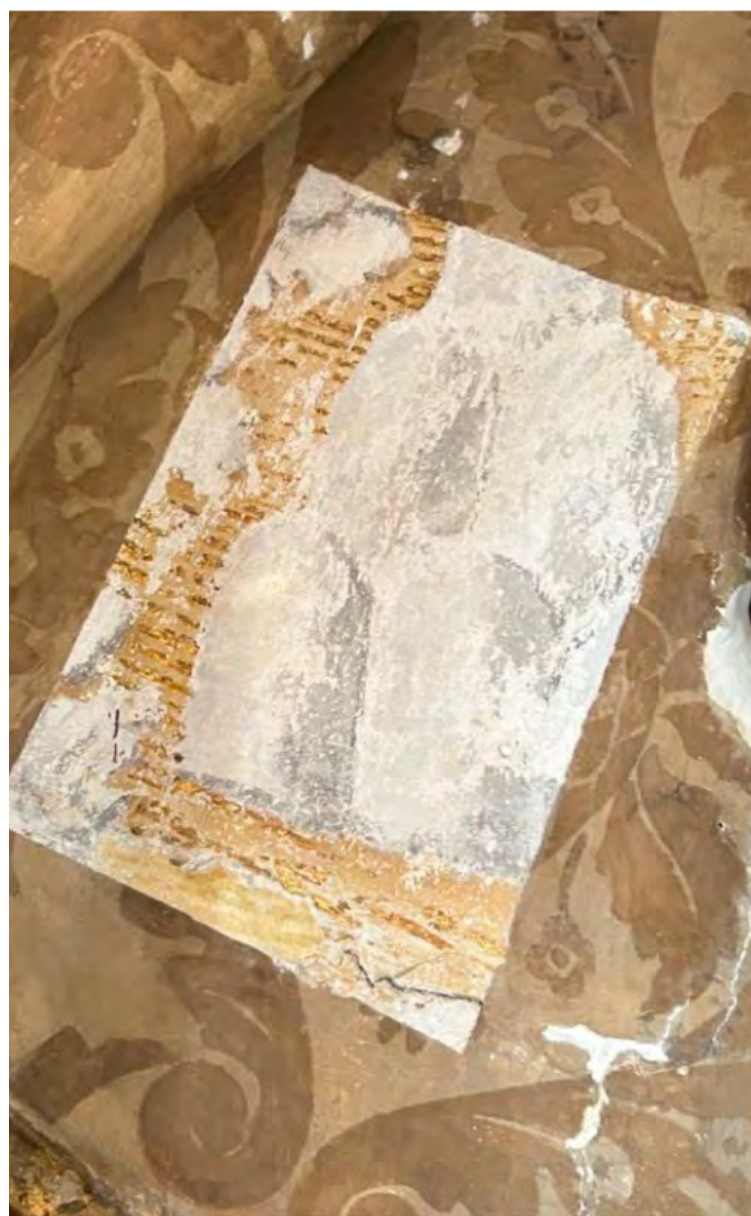
Details of the eighteenth-century engraving and the corresponding cleaning areas

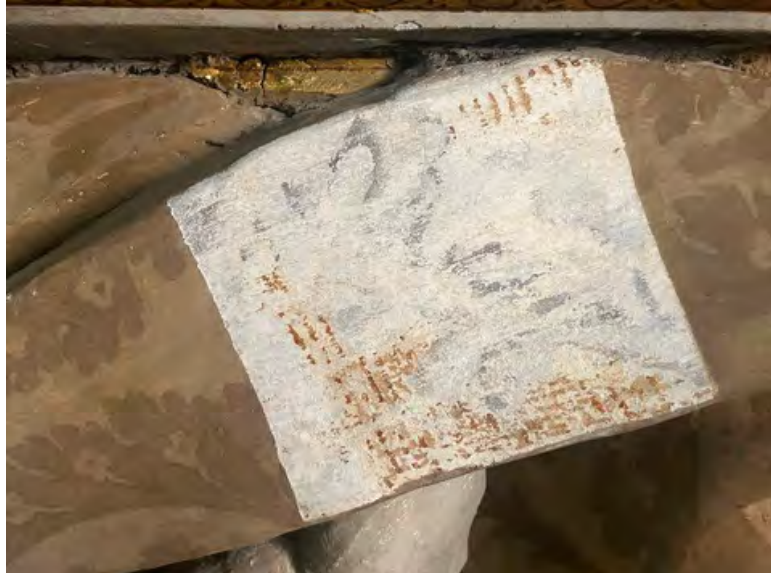
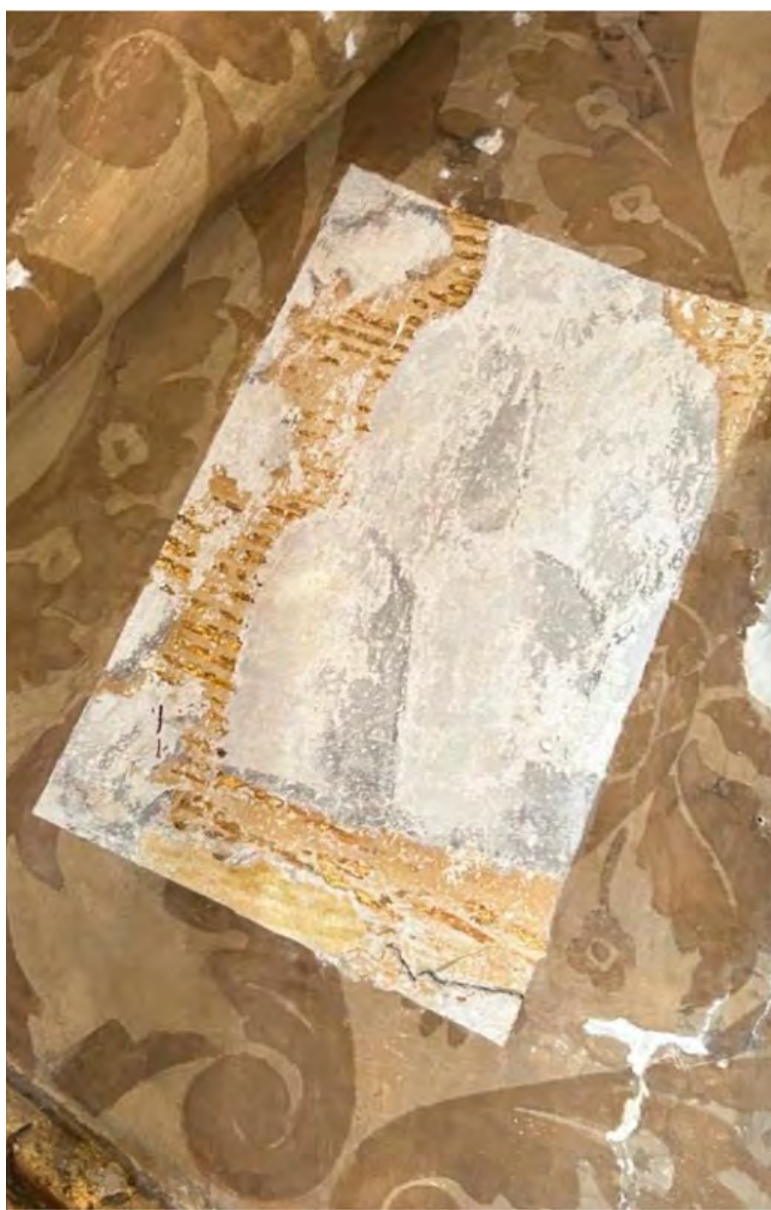
Details of the eighteenth-century engraving and the corresponding cleaning areas

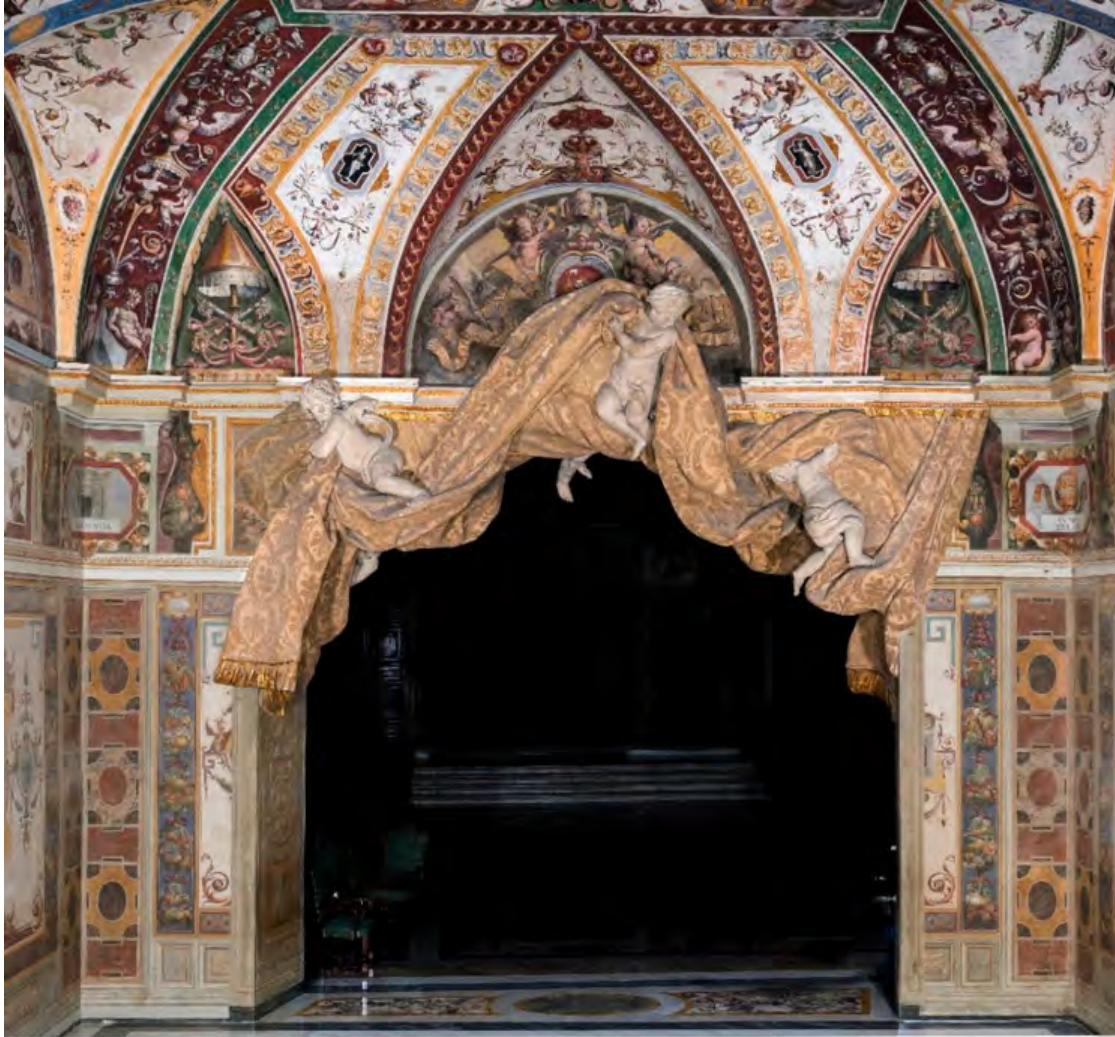
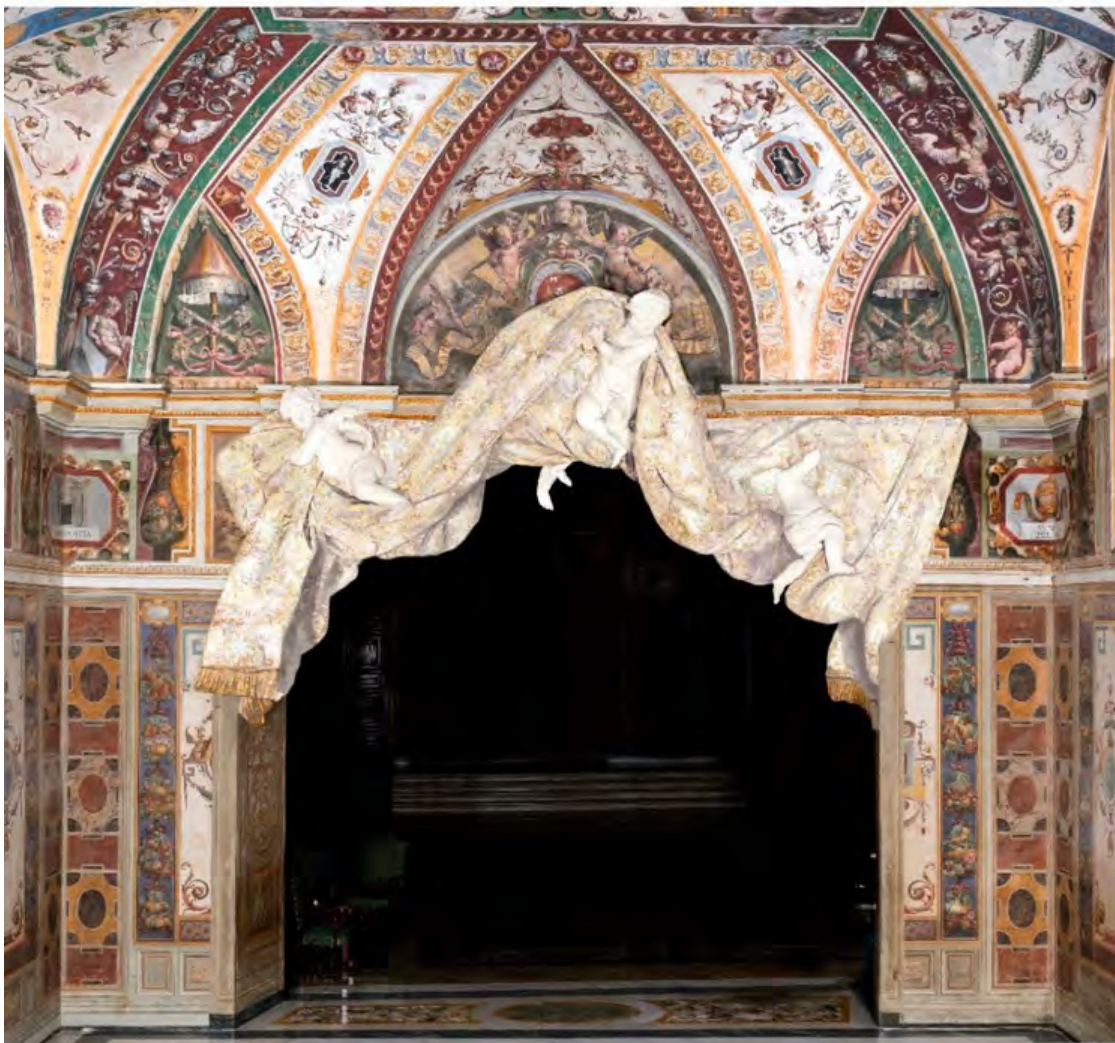
Rendering of the Bernini curtain

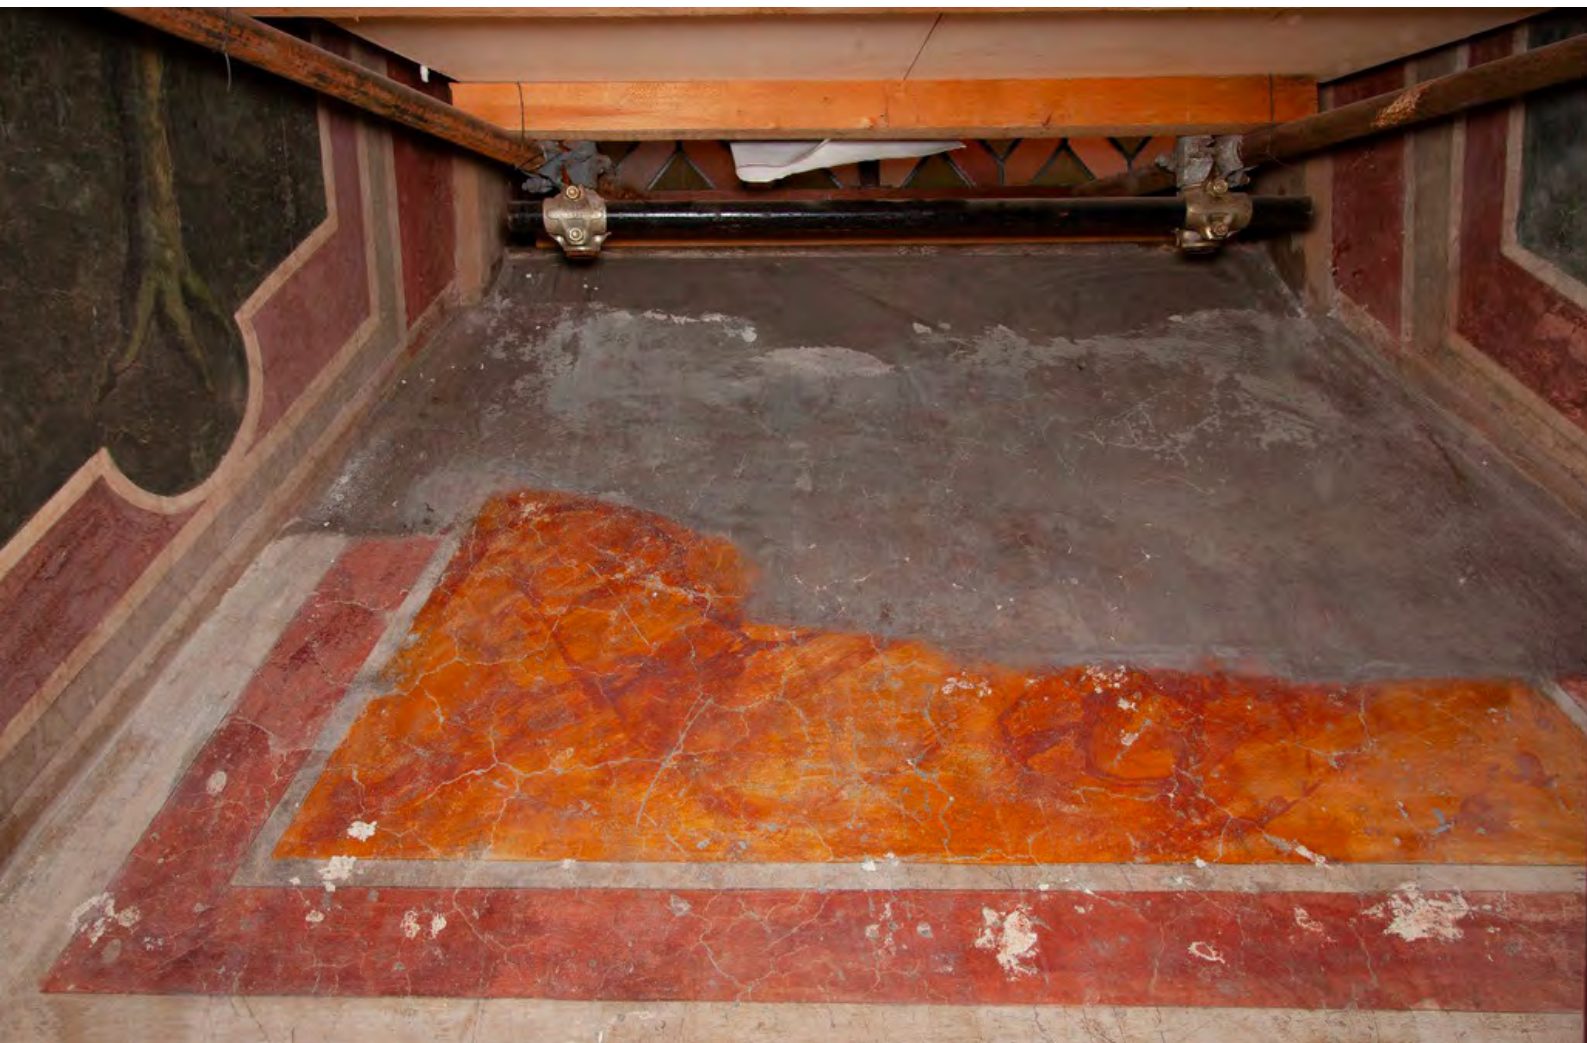
The discovery of the seventeenth-century decoration under the gray tint in the window wells

Many parts of the original decoration had been obliterated by gray-colored layers, as in the sloping surfaces at the base of the window openings, whose 17th-century faux-marble squares, painted after the enlargement at the bottom of the openings, had been completely obscured.

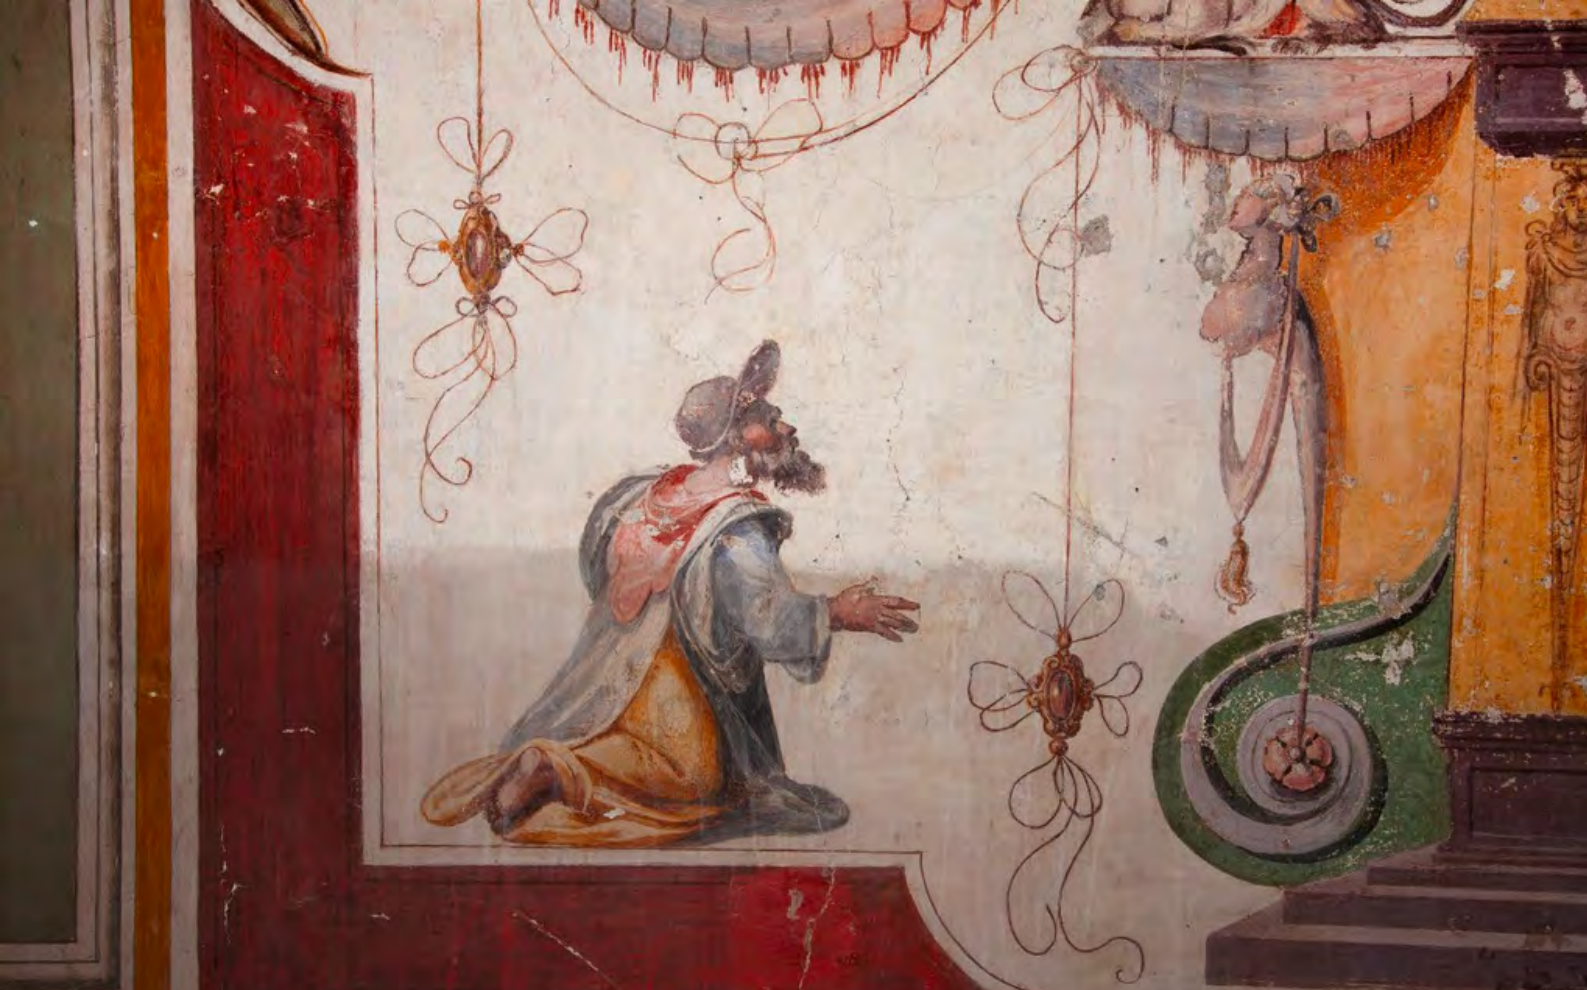
Cleaning of the 16th-century decoration of a window compartment

Still within the window wells, the sixteenth-century parts recover their bright and vivid colors in harmony with the decoration of the vault. The very high pictorial quality of the landscape paintings is revived by the cleaning, although the paintings in this area of the walls are very damaged, from cracks and nail holes inflicted at different times.

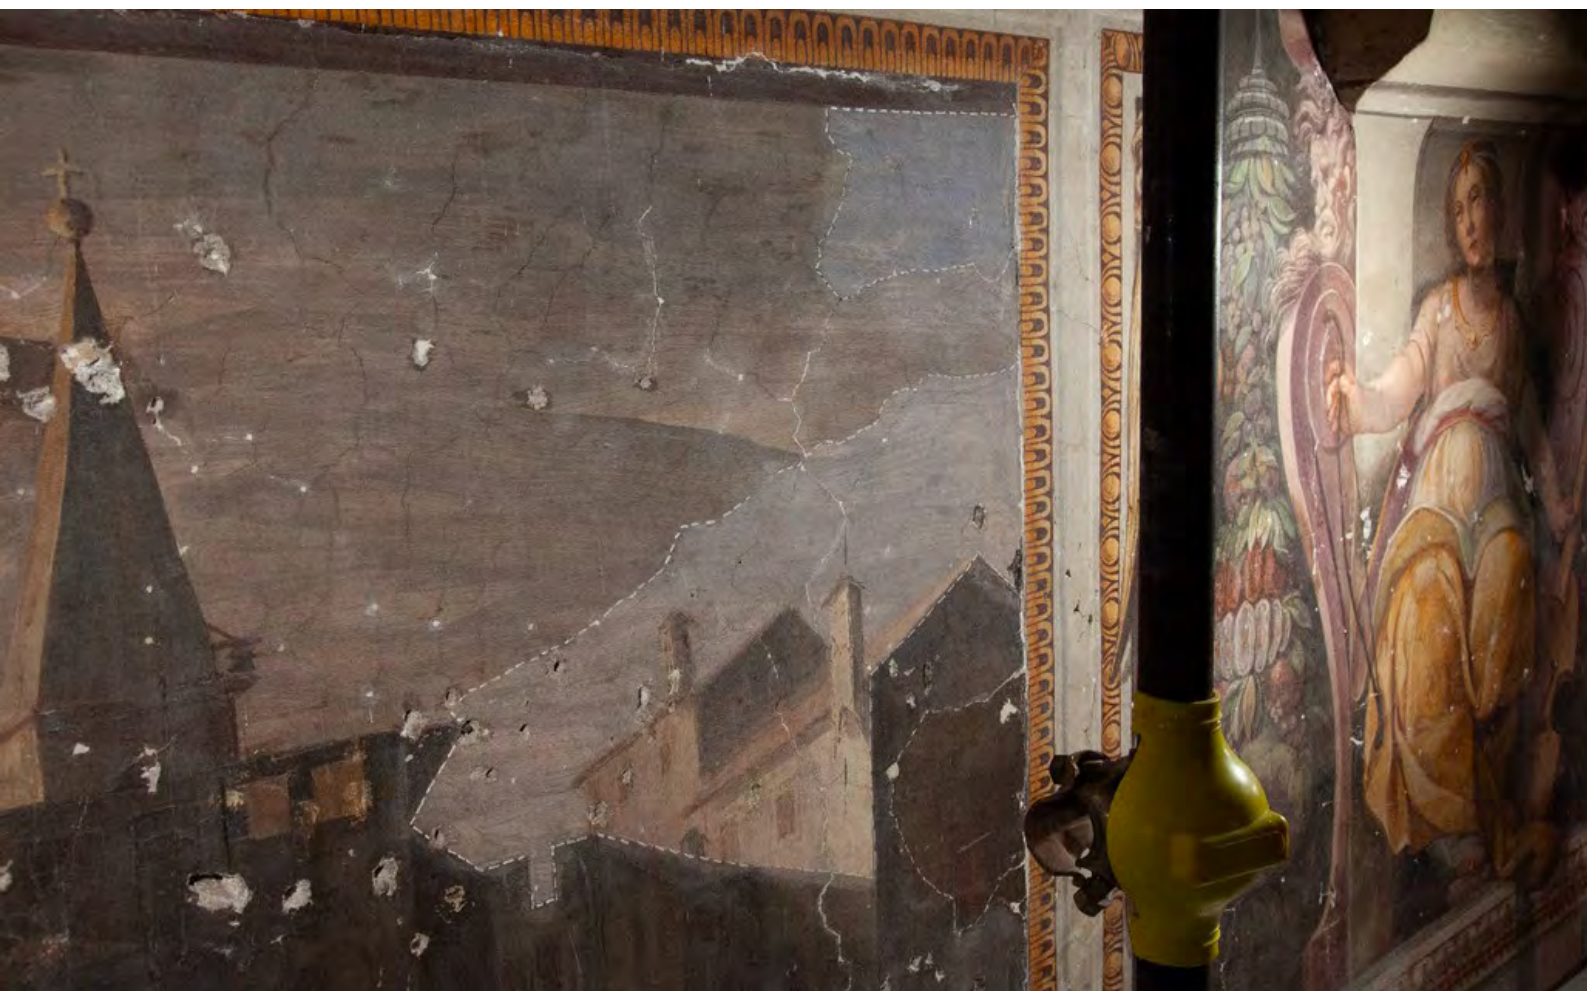
The cleaning of a landscape
