Ducal Hall in the Apostolic Palace

**ONGOING RESTORATION REPORT
FEBRUARY 2024**

Restoration of the paintings of the vault, lunettes, frieze, and Bernini curtains

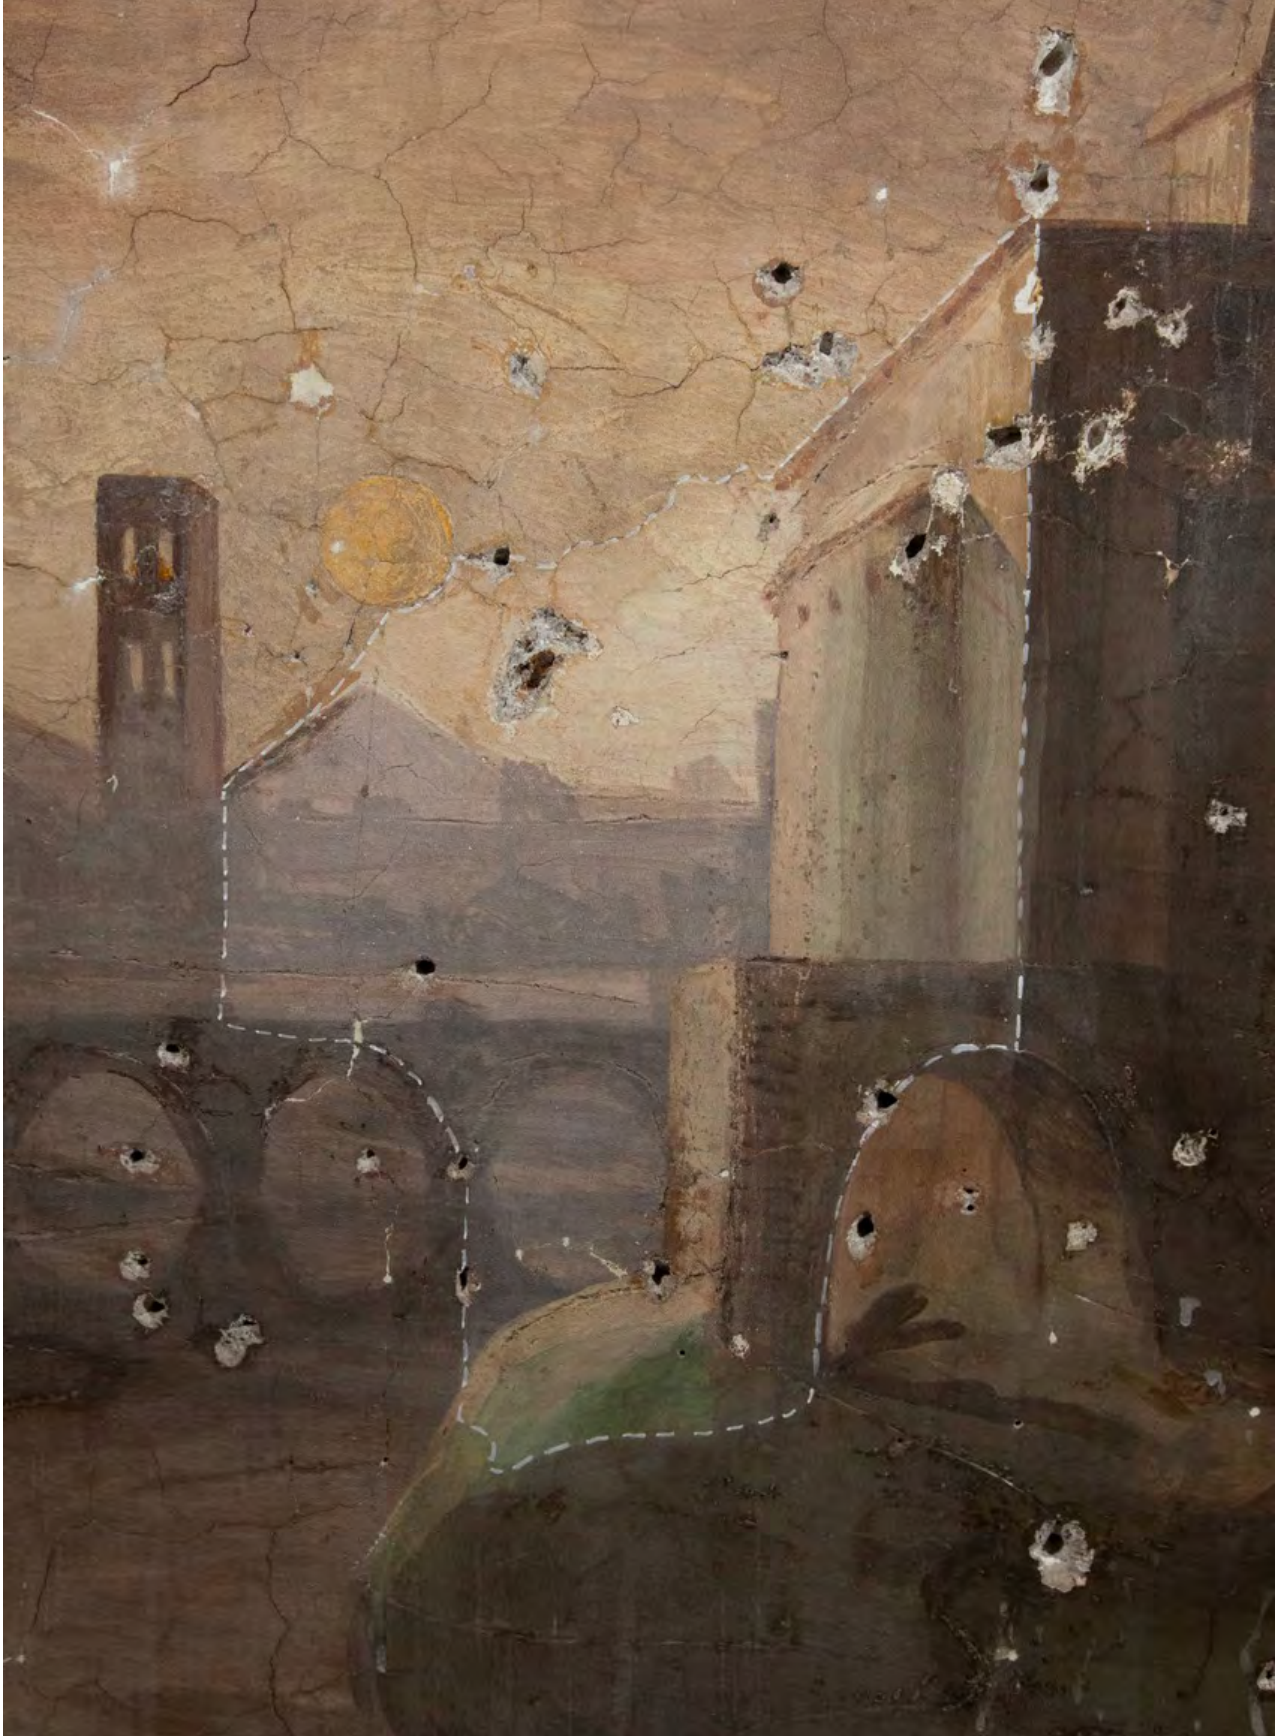
Cleaning the landscape with nocturnal scene

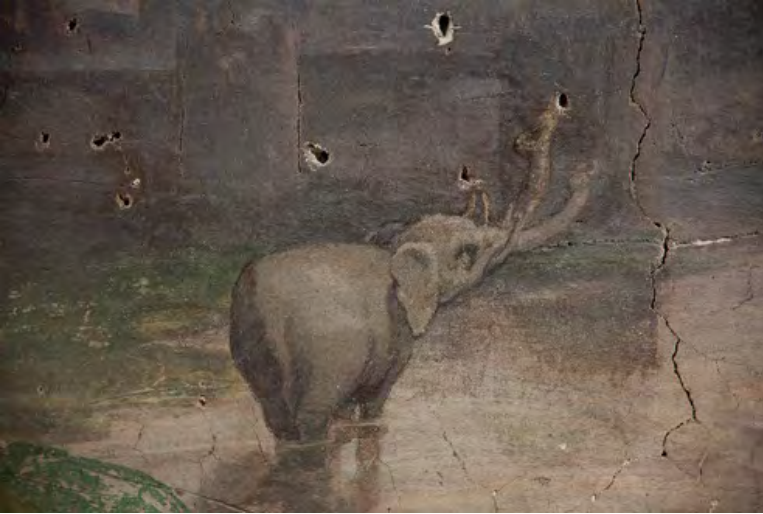
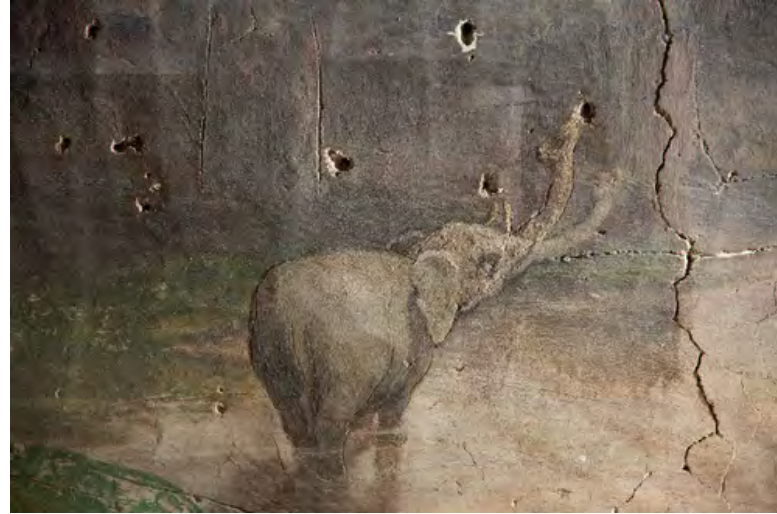
Detail of the elephant in diffuse and grazing light

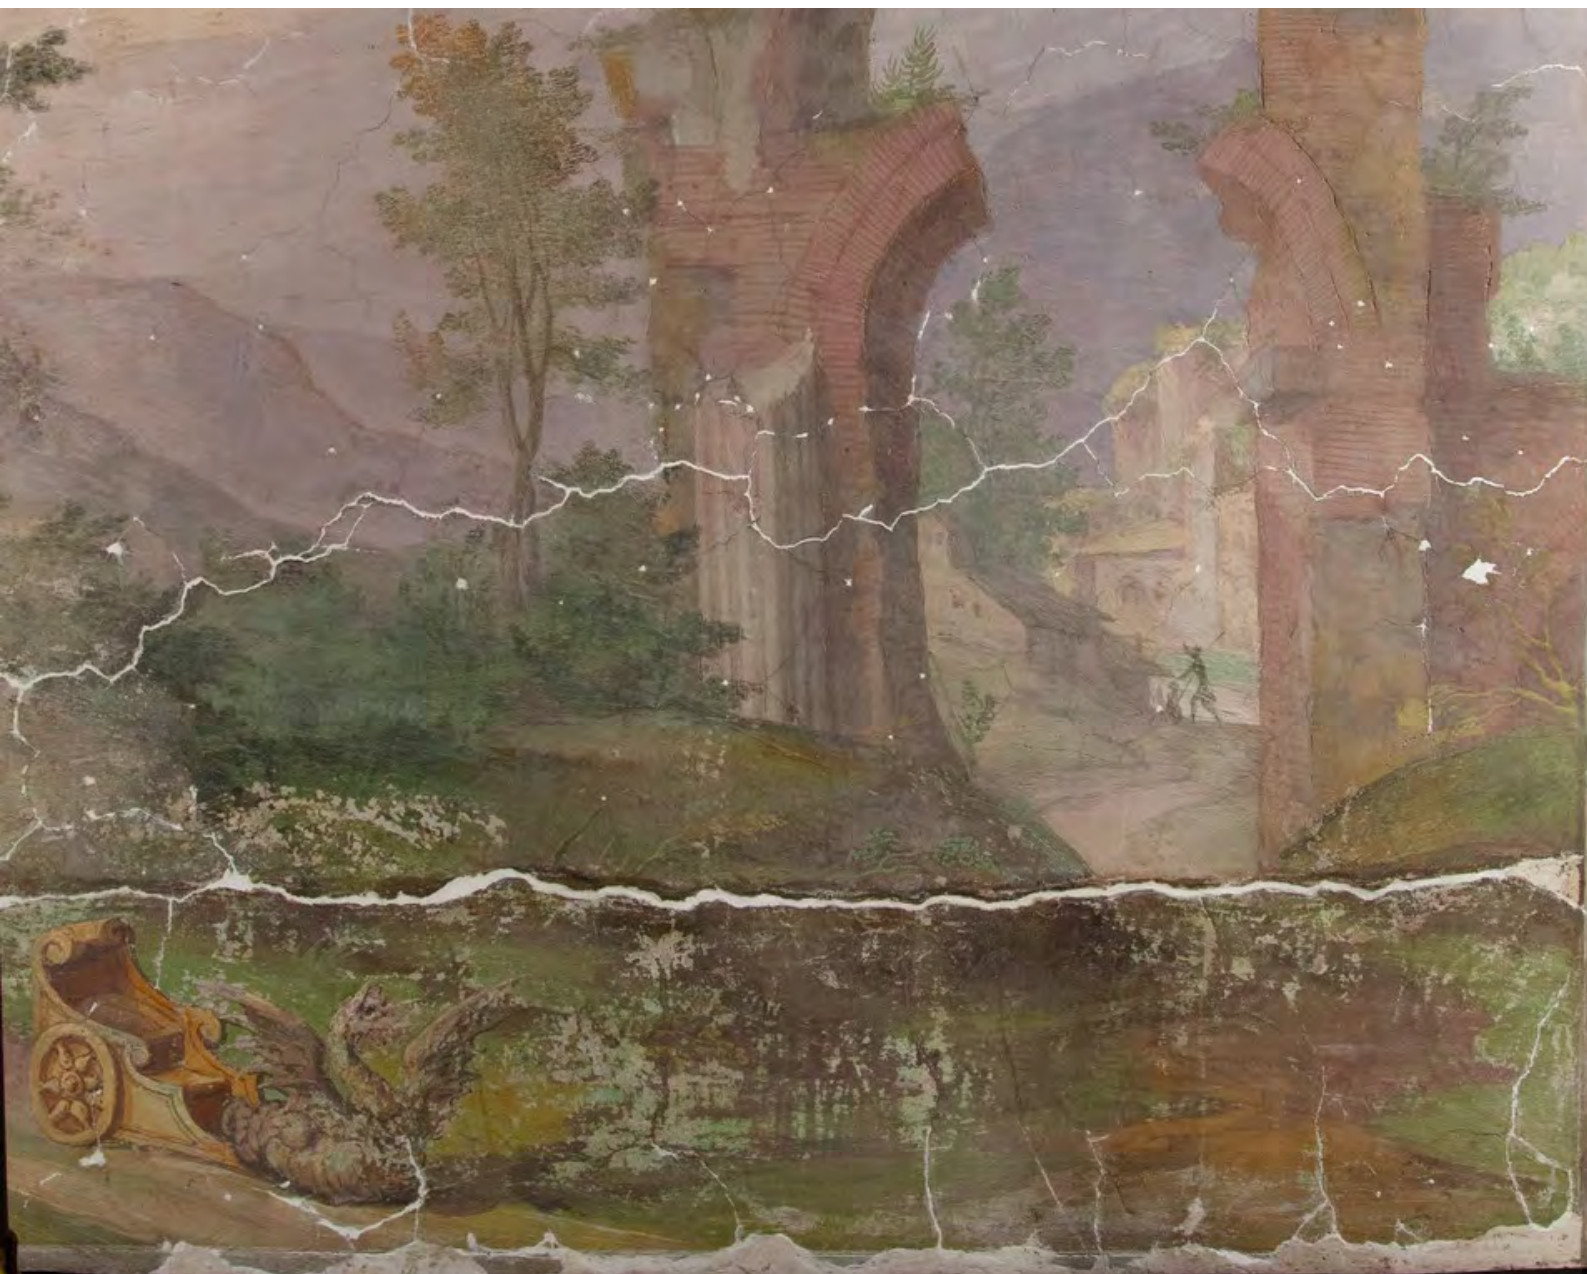
Gap plastering

Currently, the operations to consolidate the entire frieze and clean the scenes have been completed and the gaps are being filled in, and this will be followed by the pictorial reintegration.

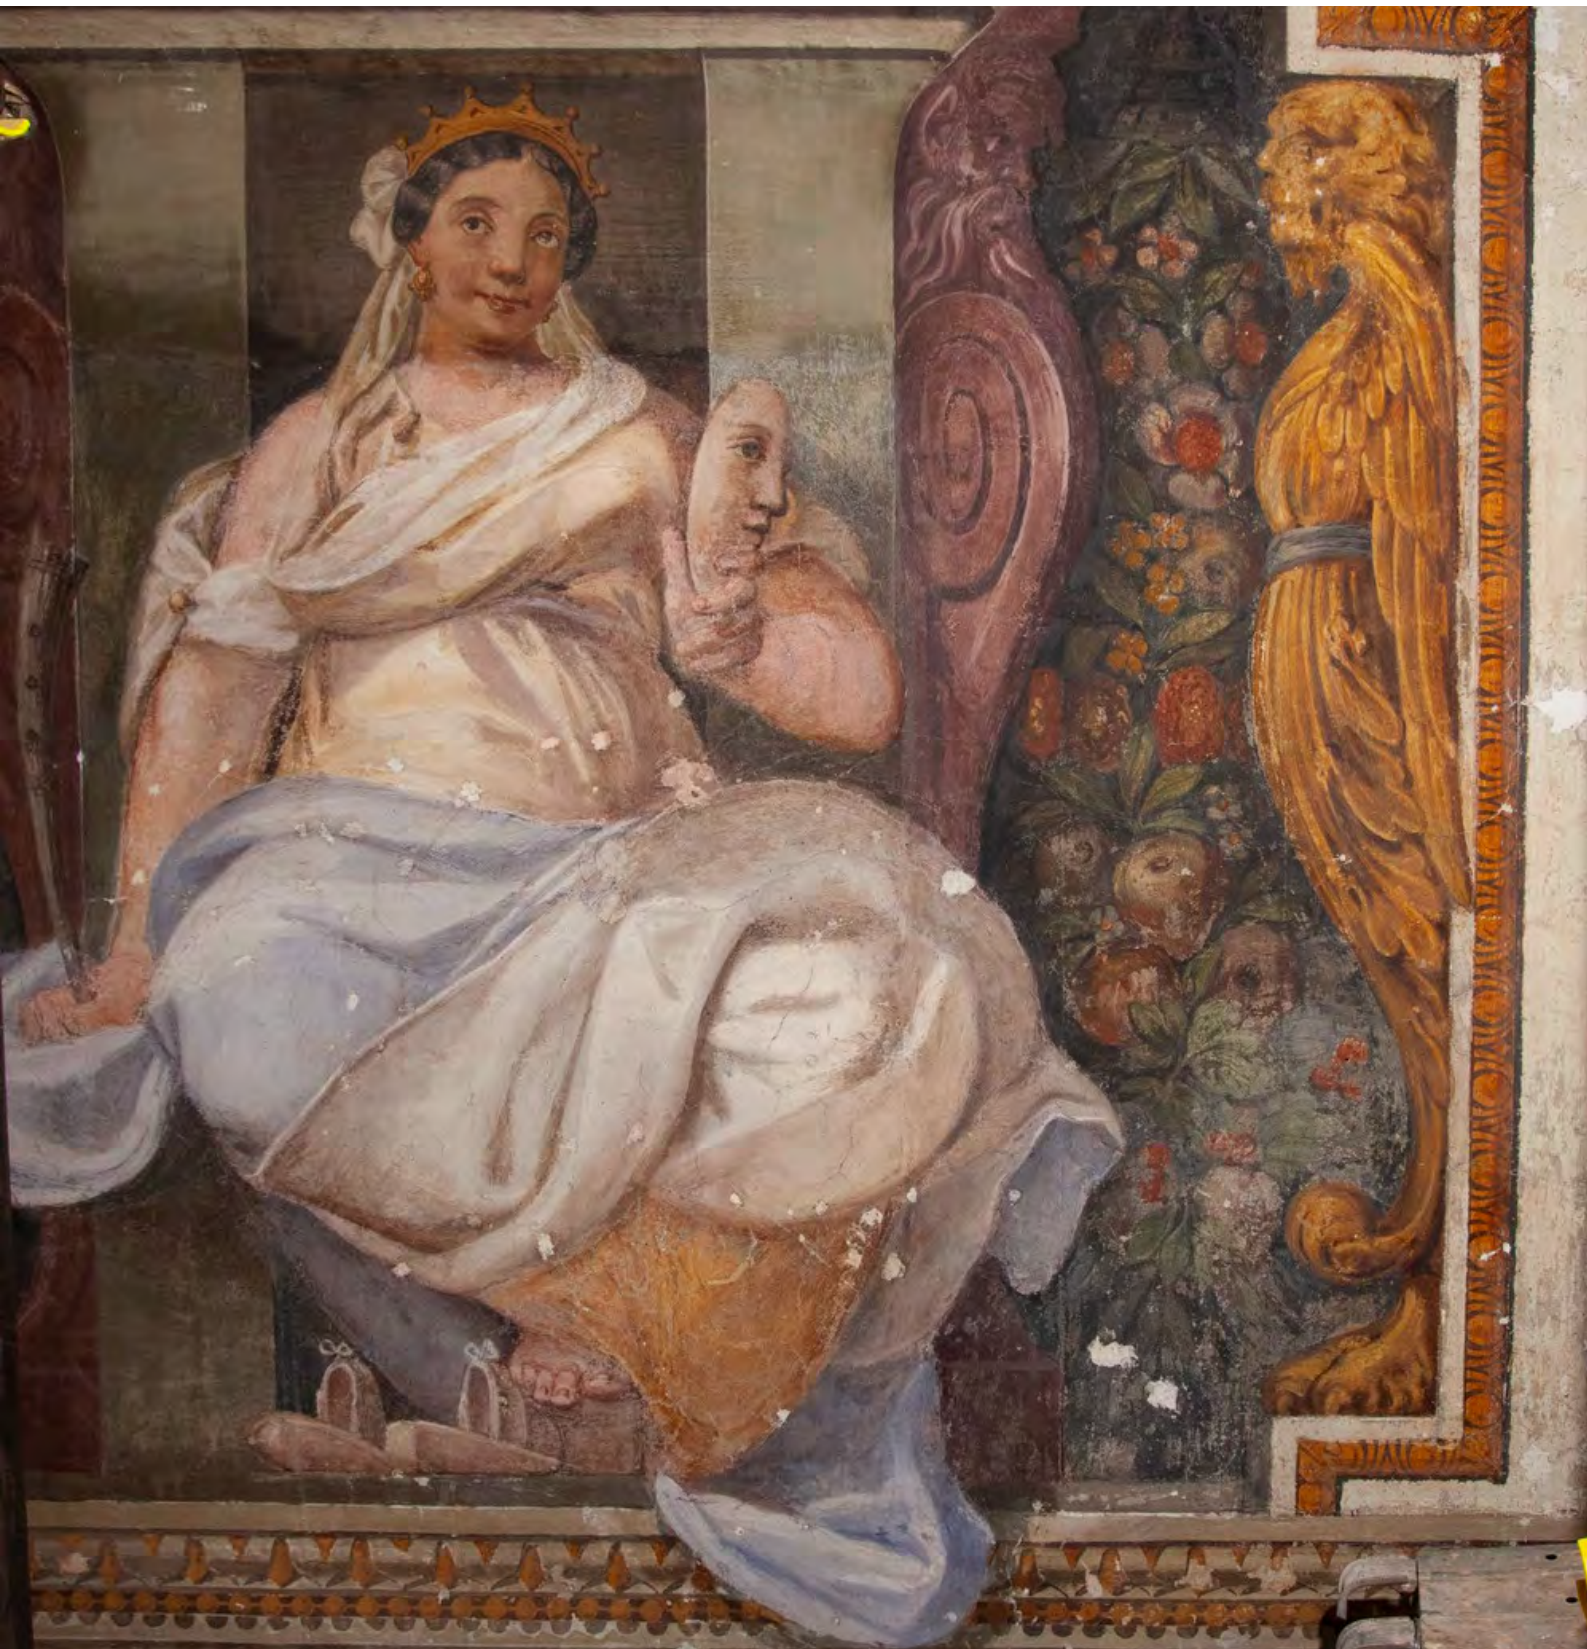
One of the female allegorical figures after cleaning

In the cleaning carried out on the allegorical figures, the restorer had to try to connect the sixteenth-century parts with the darker-colored nineteenth/twentieth-century remake parts, which affect all the heads, redone for the changes in the capitals. With the pictorial reintegration, the restorer will have to recreate a pictorial continuity between the parts of different shades.

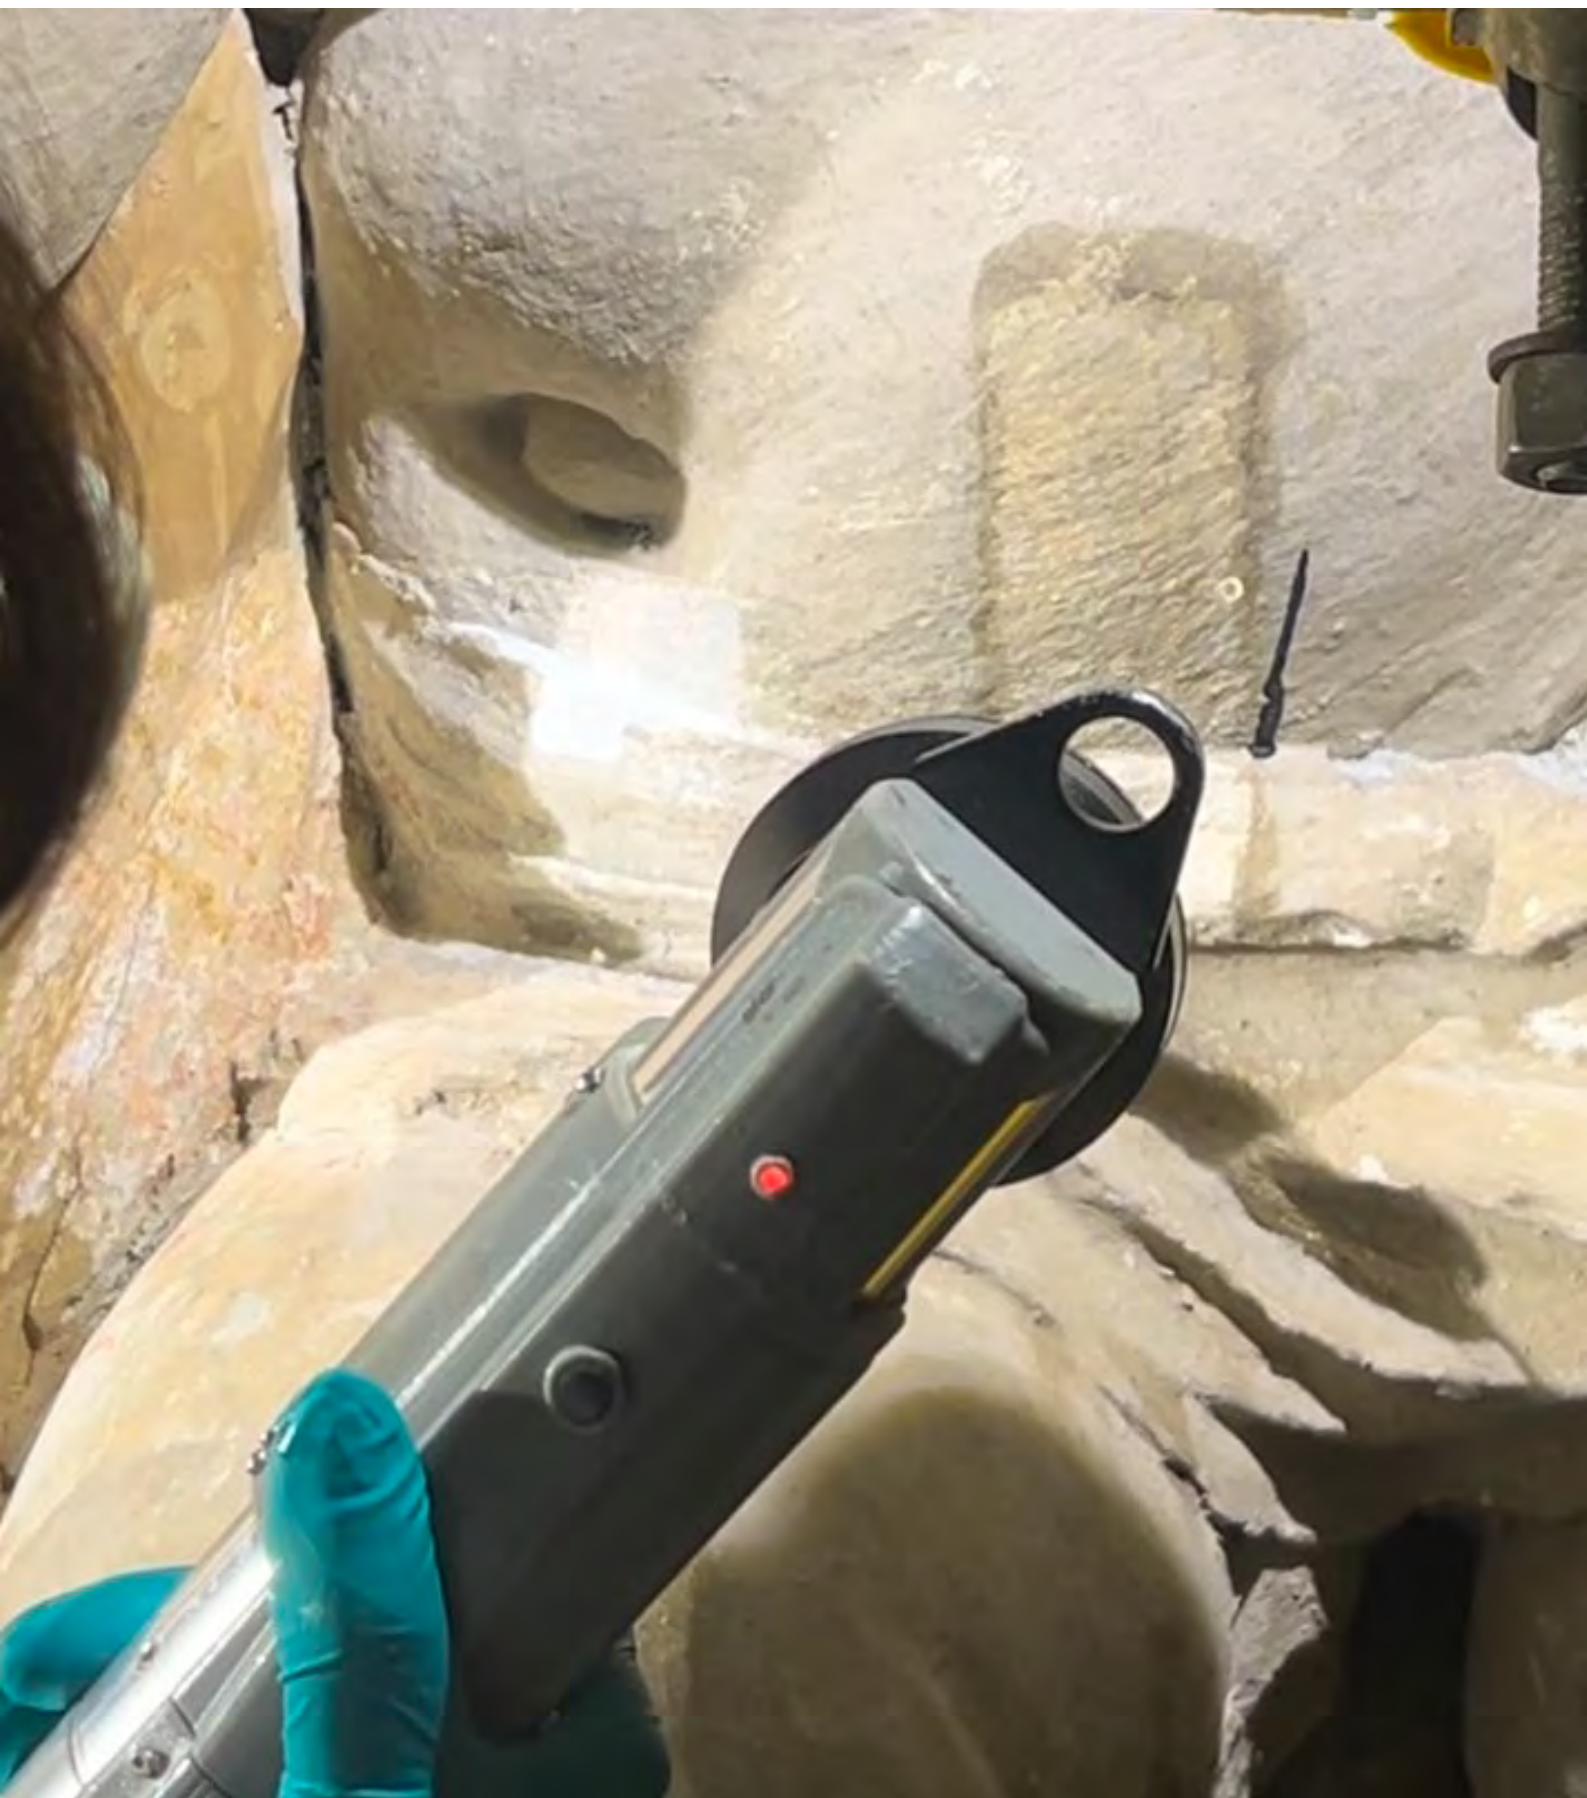
Cleaning using a laser

At the same time, cleaning tests are continuing on the various surfaces of the Bernini drapery, where restorers have been using lasers for some tests on the stucco of the putti, which have provided excellent results.

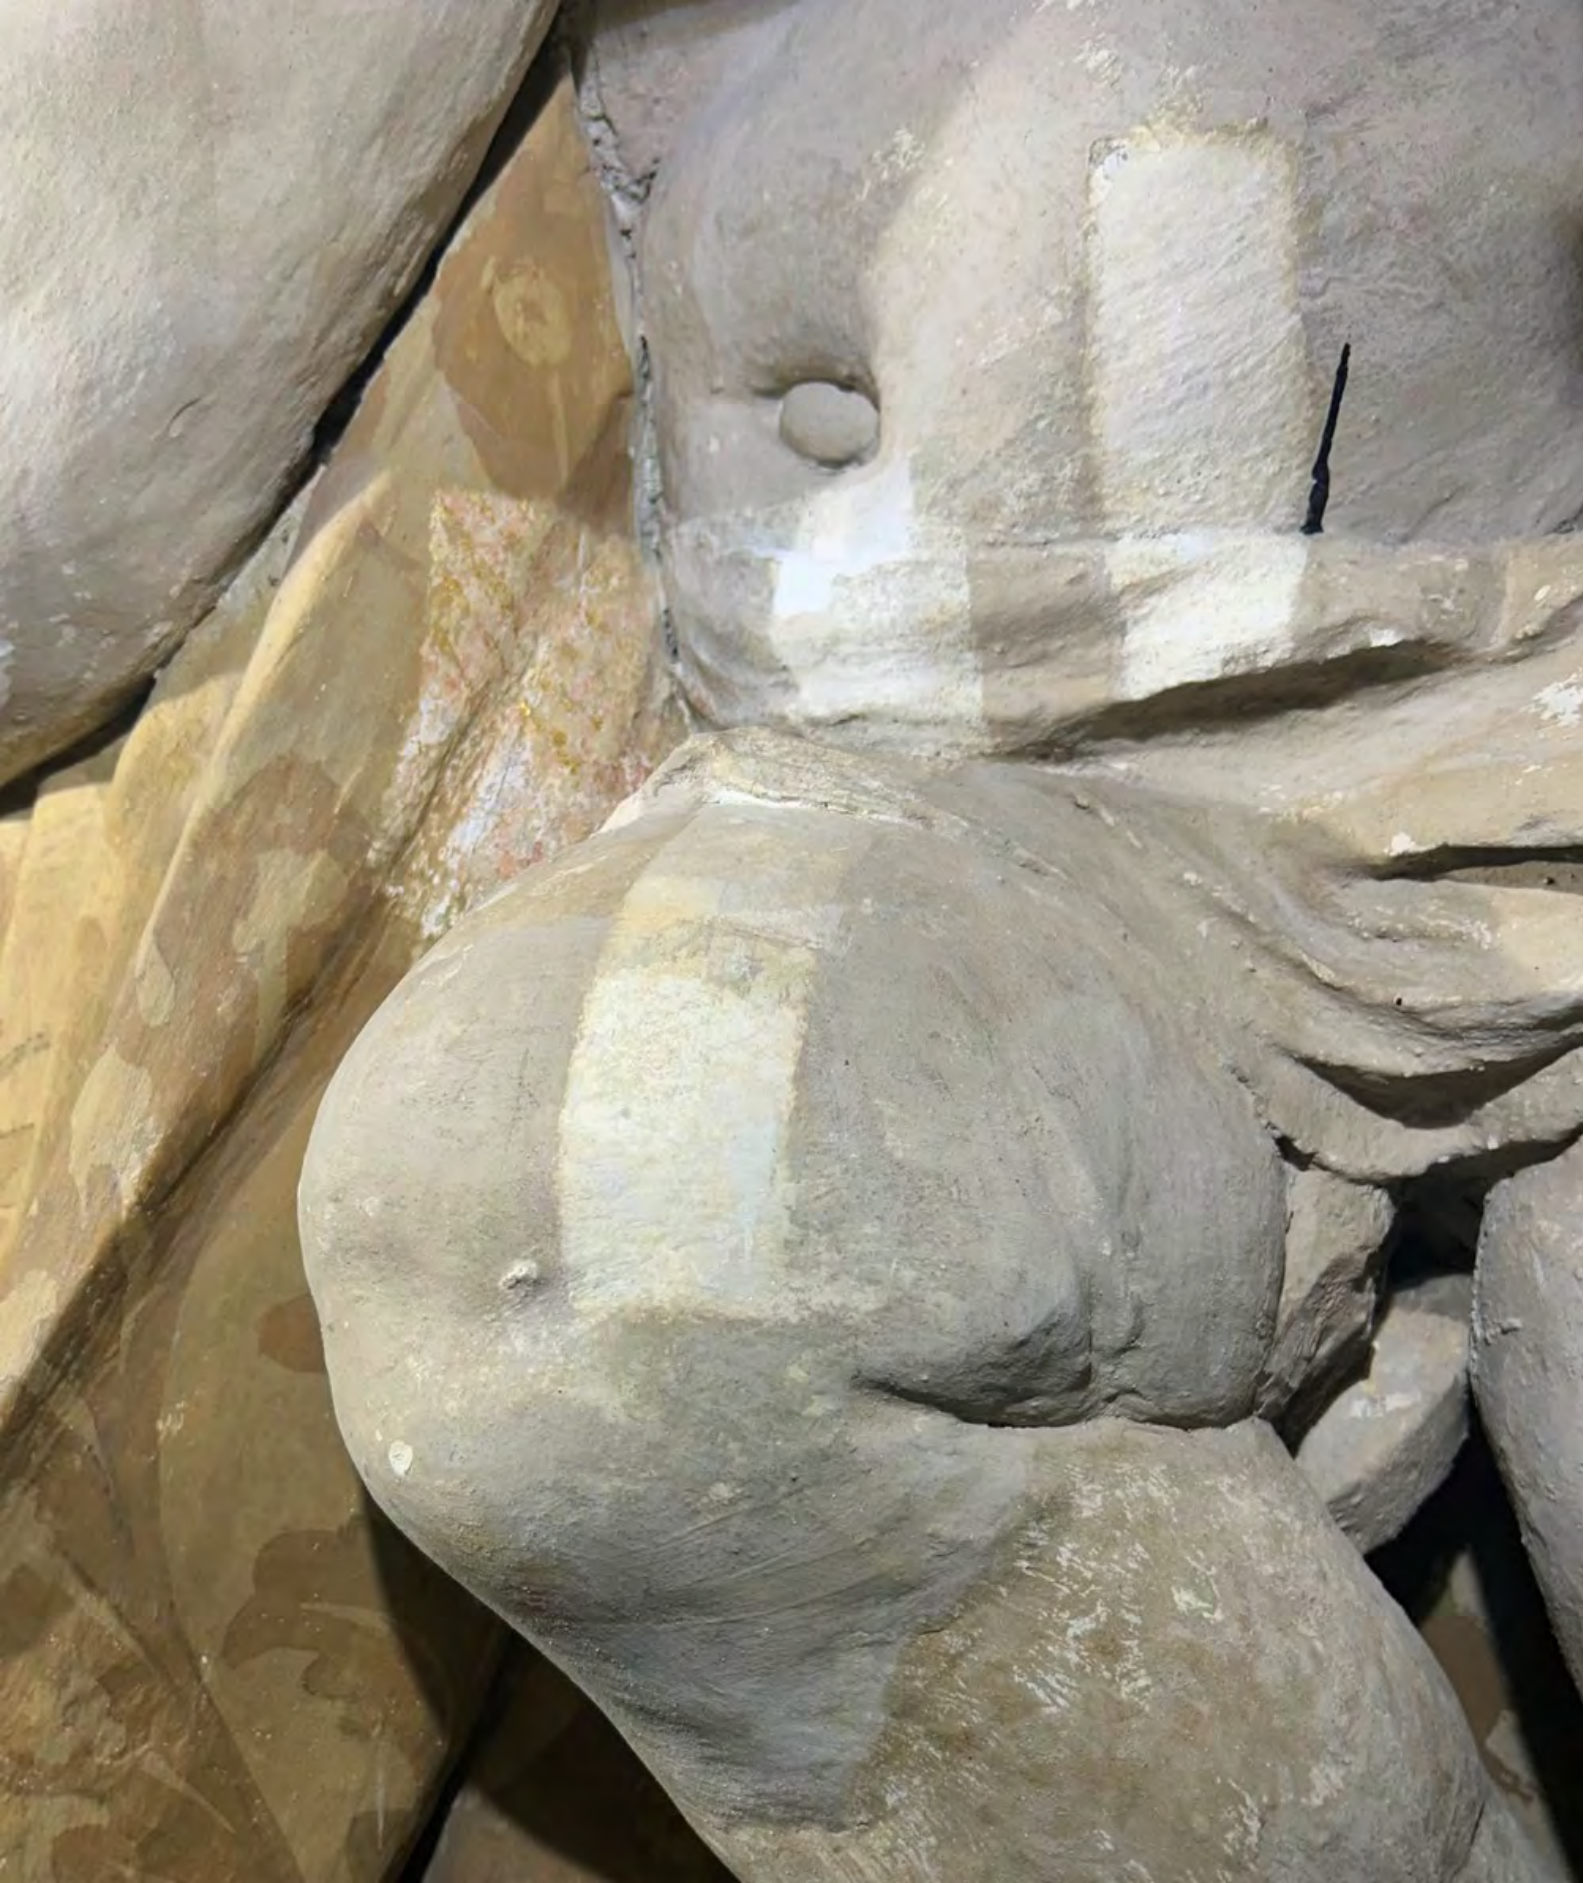
Laser cleaning tests on one of putti in stucco
