PAINTINGS IN THE SECOND LOGGIA OF THE APOSTOLIC PALACE

RESTORATION PROJECT

Code: **W04_2025**

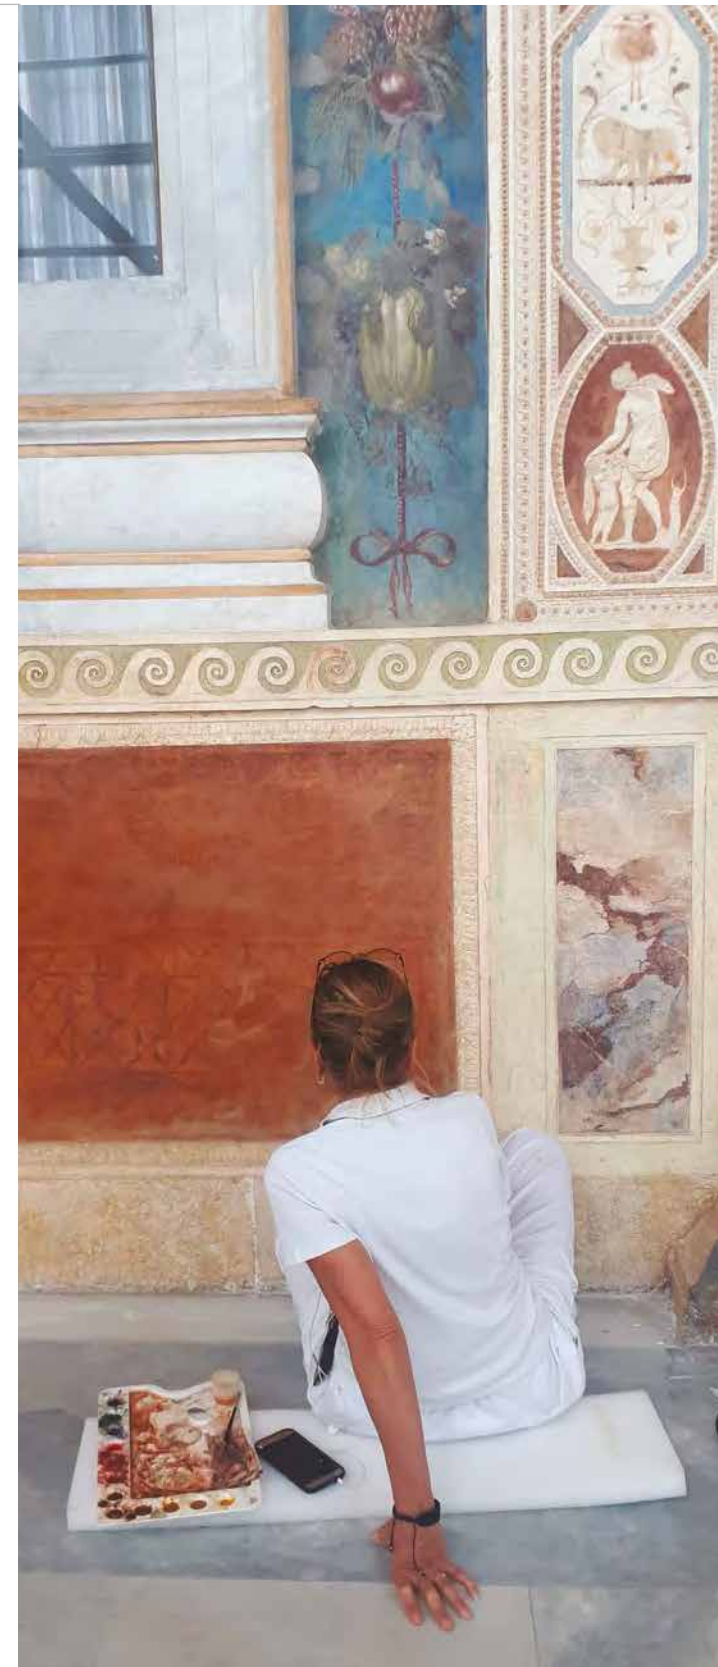
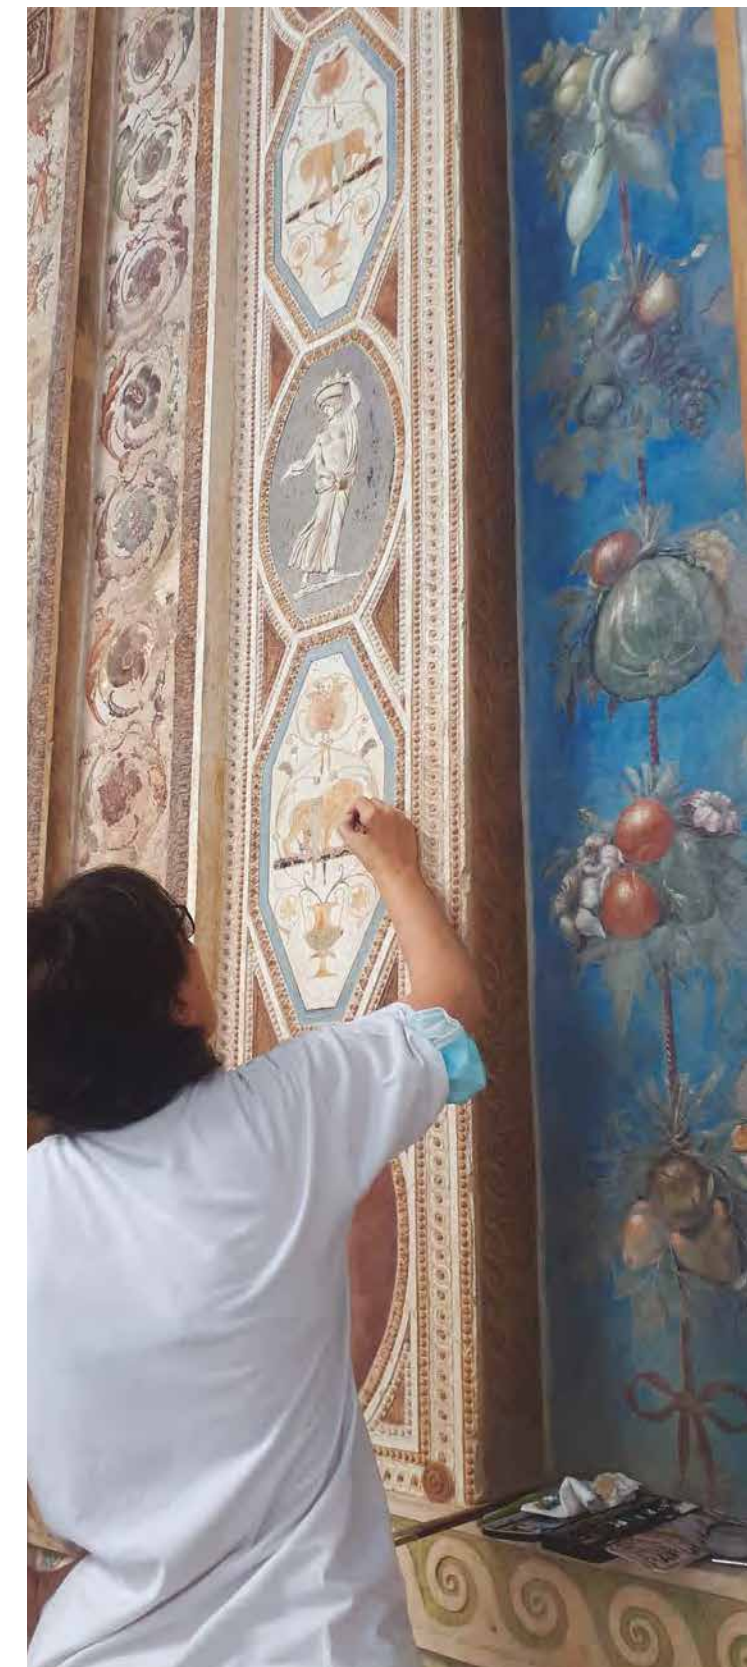
In general, where there were traces of the original layers of paint, the restorers used an ‘undertone’ or a light watercolor glaze of a single tone to reproduce the lost outlines of the figures, reconstructed using various techniques; where the surface was illegible, they used reproductions made by copyists over the centuries. Thus, on the pedestal, an element with a “supporting” function both structurally and aesthetically, it was possible to reconstruct the biblical scene depicted by piecing together the numerous fragments and comparing them with 17th century engravings.
