Ancona (Section of a Predella) with the “Crucifixion and Passion Scenes”

**FINAL RESTORATION REPORT
JULY 2024**

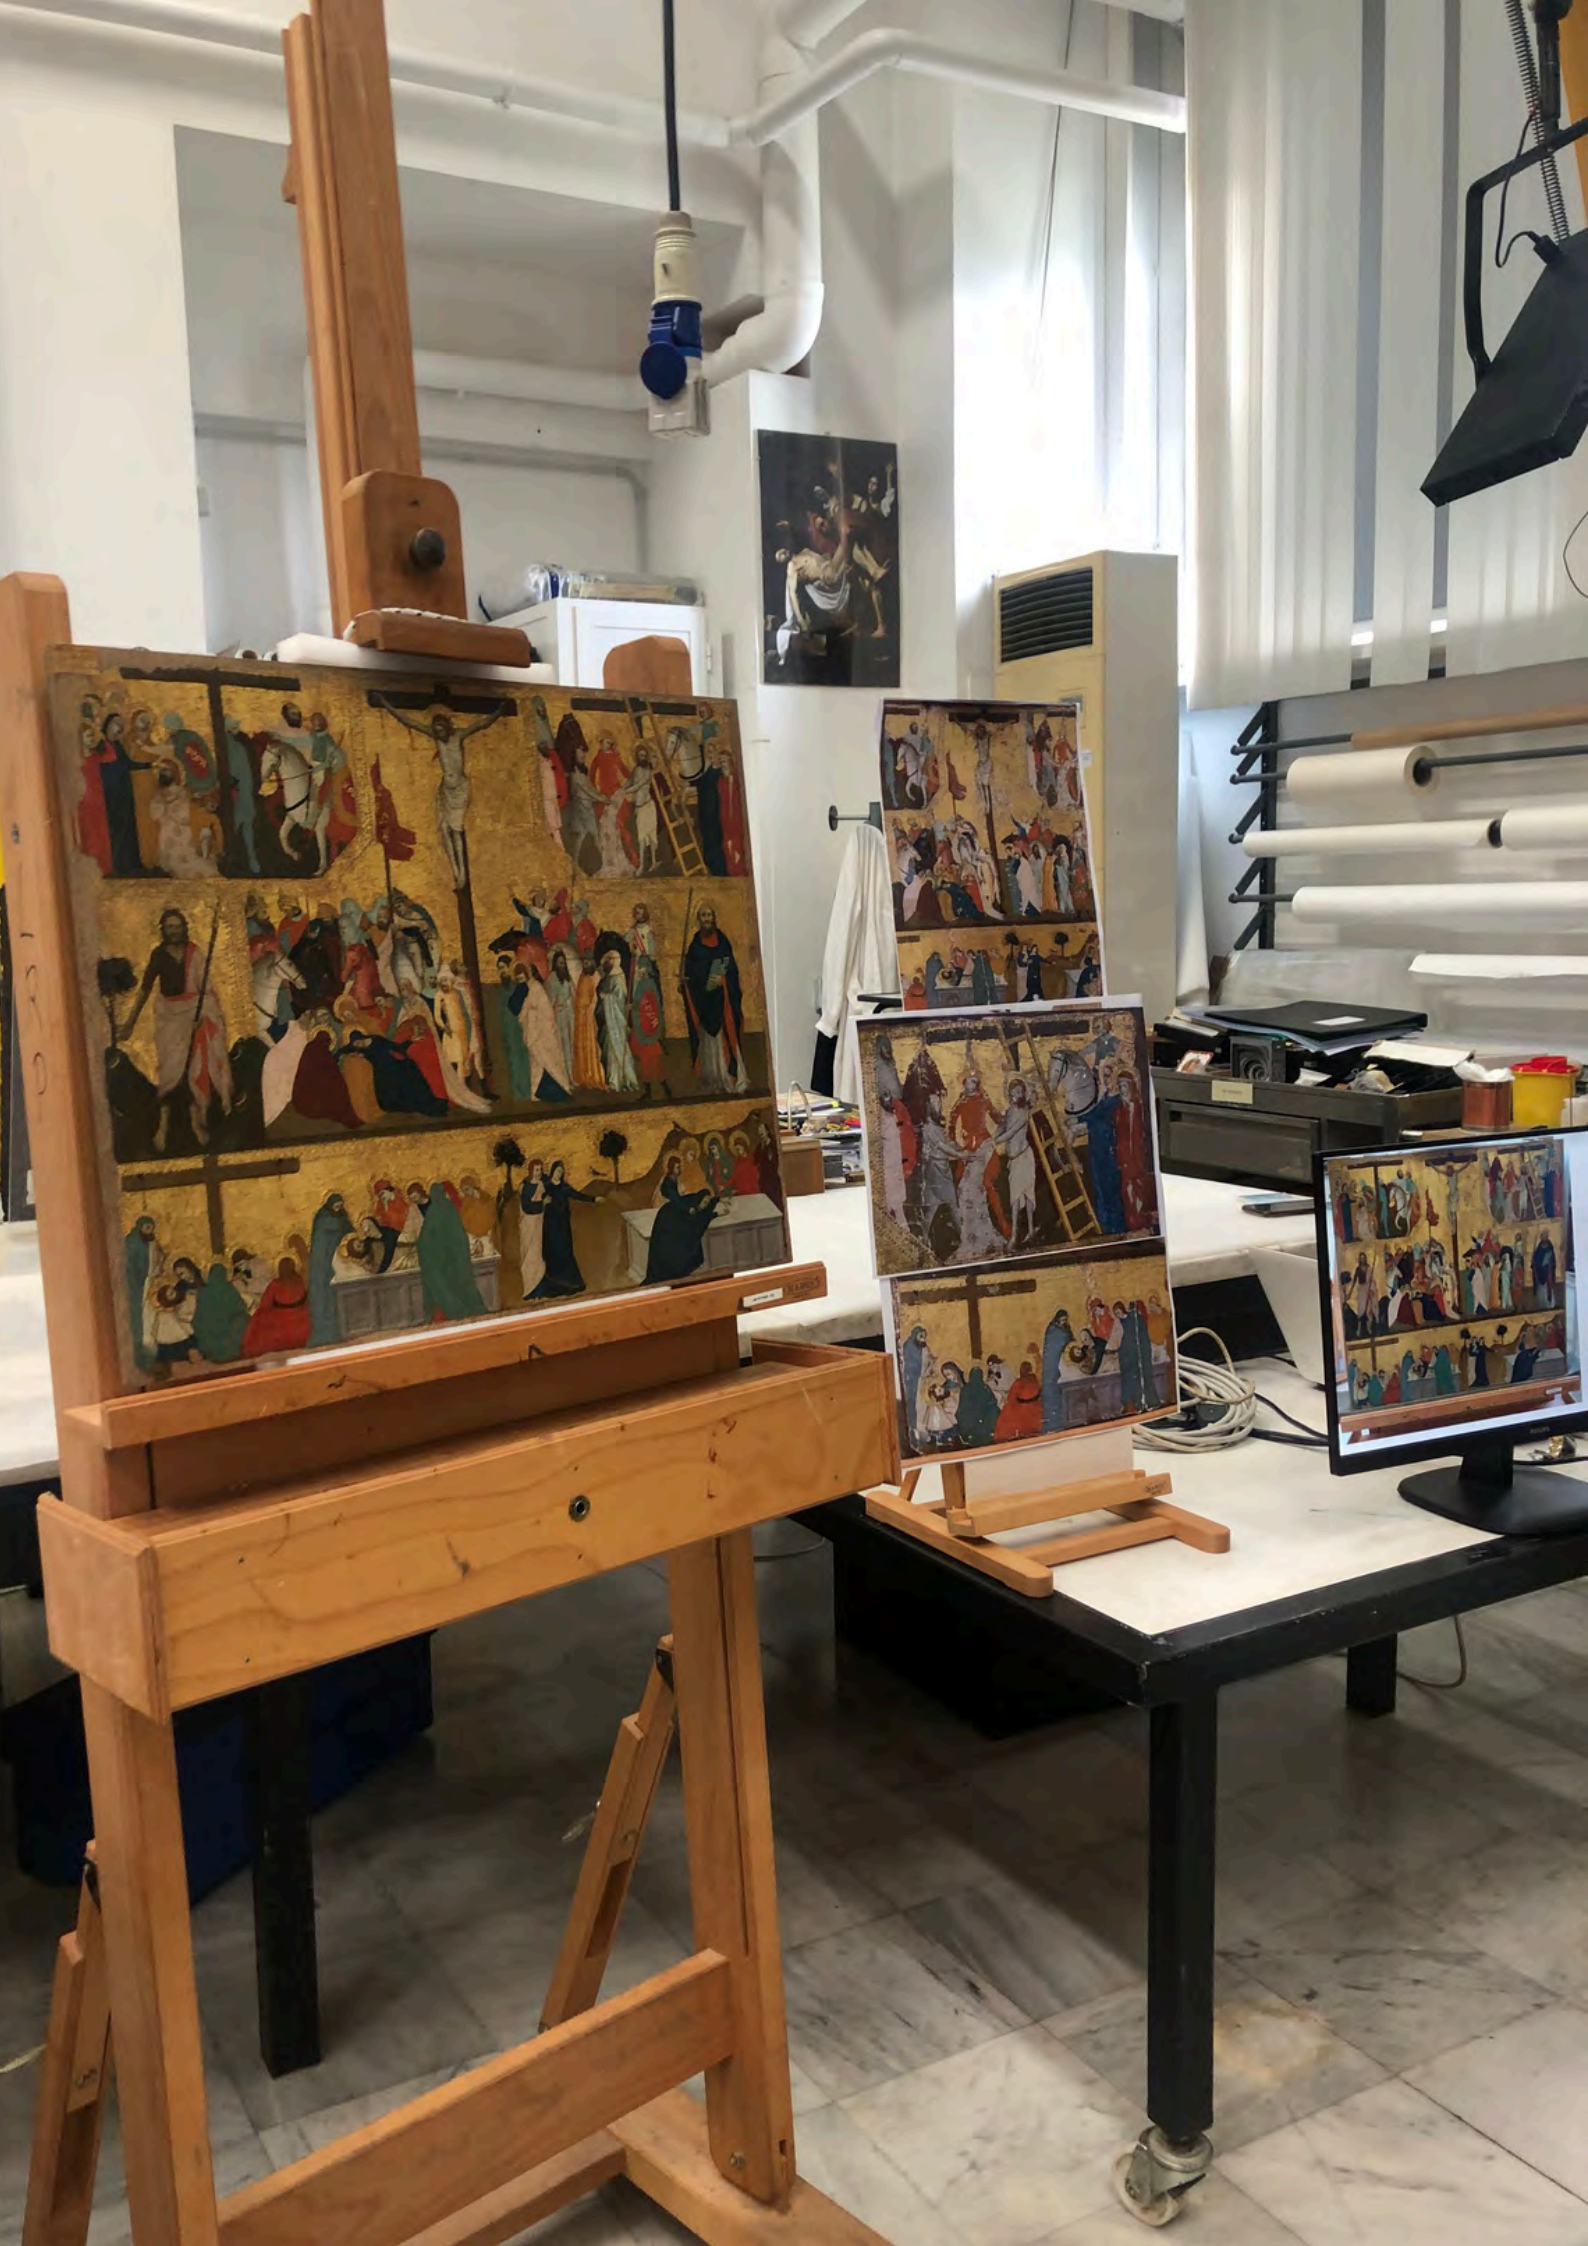
As a result of the retouches and the protective varnish of the latter restoration, as well as the original blue pigment of some of the drapery, which had now changed to black, the painted surface appeared chromatically altered; in addition to the structural problems already mentioned, there were also numerous lifts of the paint film in the lower register.

Lifting of paint film

After fixing the lifts with a suitable opaque consolidant, the restorers from the Wood Laboratory restored the structure of the painting. Restorers tested various solutions and methods to remove the overlying layers while fully respecting the original layers.
